SINGAPORE ACCIDENT STATEMENT

ACCIDENT STATEMENT

AUTOMOBILE ASSESSMENT REPORT

Assessment of Vehicle No : PC 5108 K

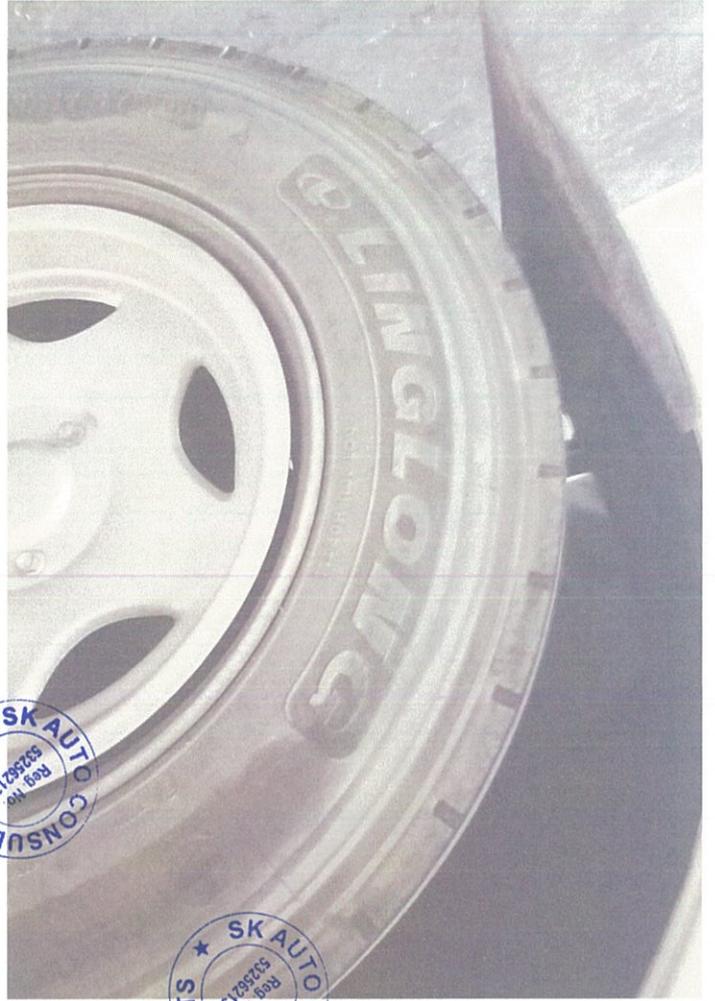
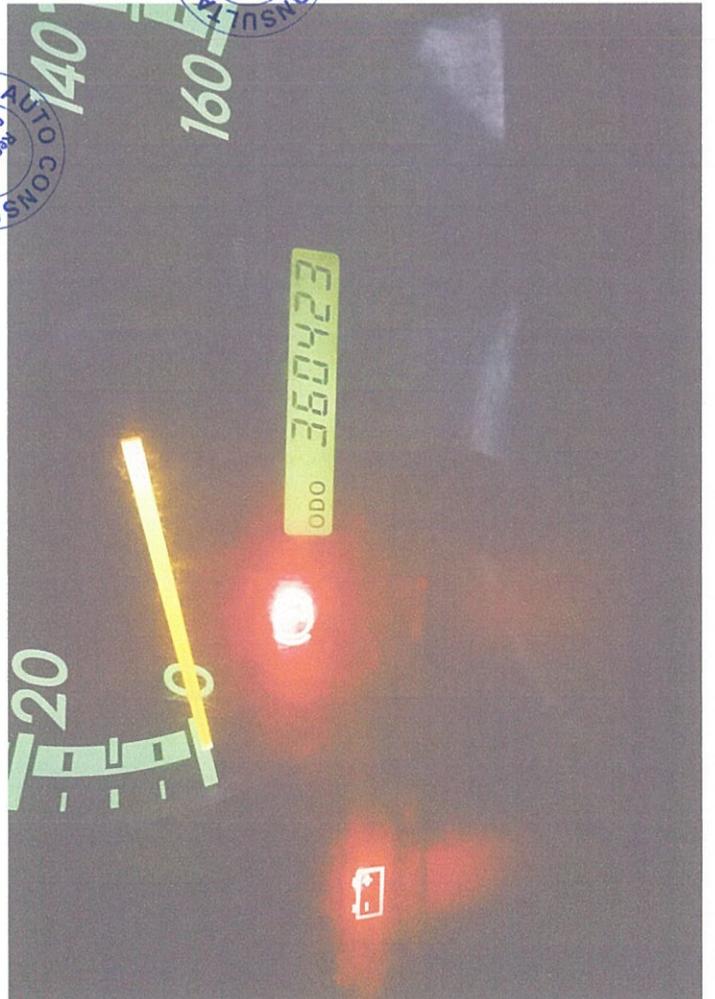
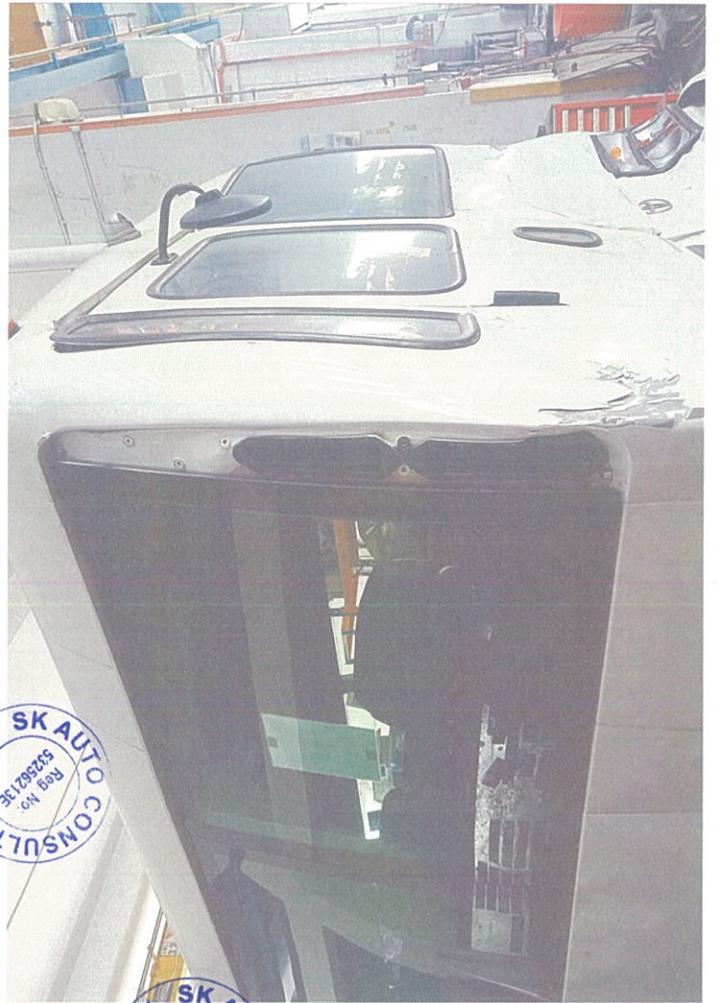
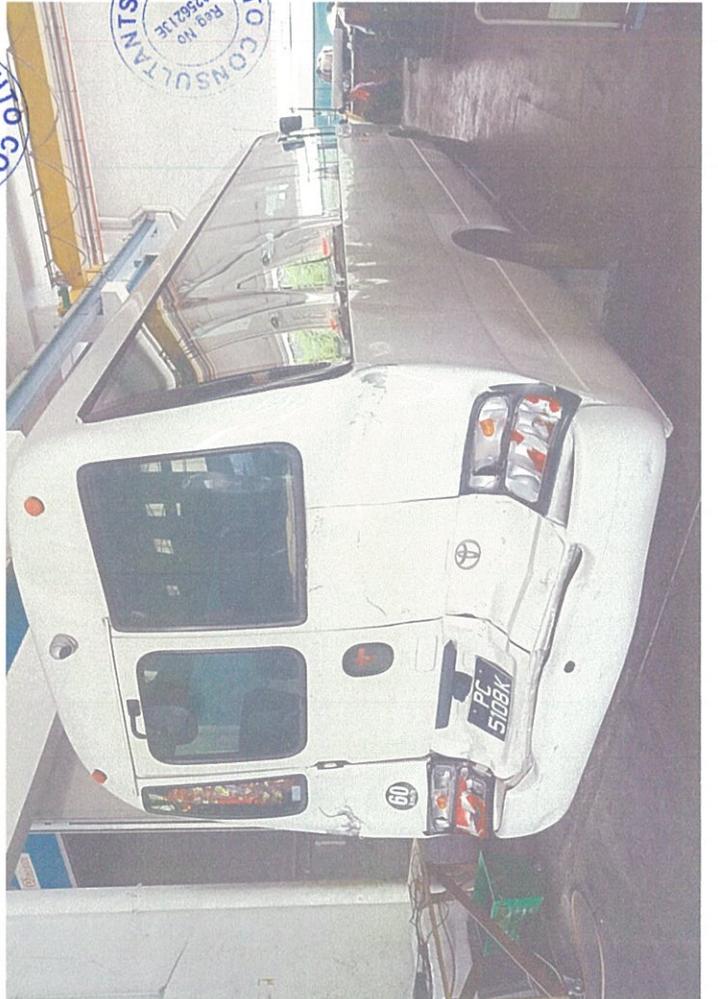
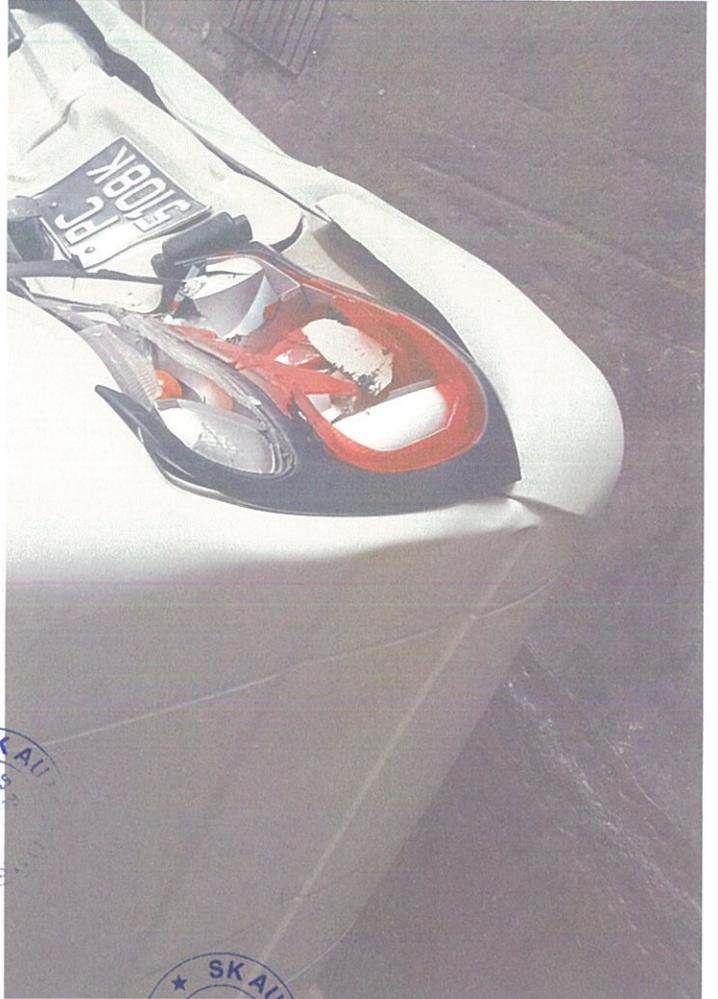
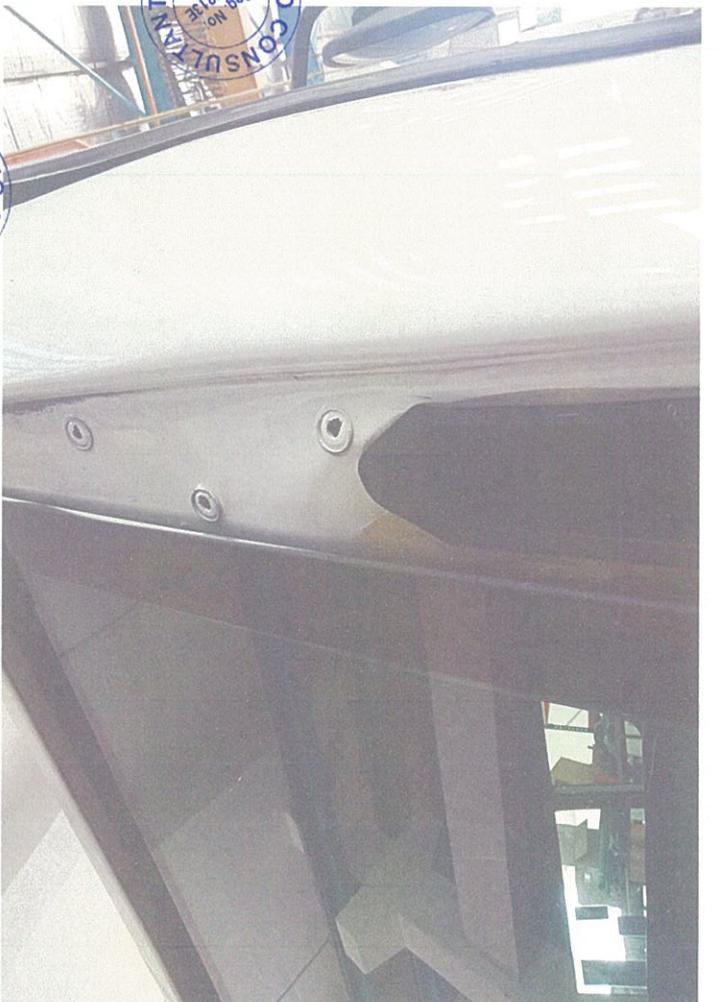
At the time of inspection observed that this vehicle had sustained damages to the Rear portion

QTY	DESCRIPTION	CONDITION	REPAIRER'S ESTIMATE(\$\$)	OUR ASSESSMENT(\$\$)
<u>PARTS (LIST ITEMS)</u>				
1	Rear bumper	Distored	1450.00	1450.00
1	Rear bumper reinforcement beam	Distored	850.00	850.00
2	LHS & RHS rear taillamp @800	Cracked	1600.00	1600.00
1	Rear RHS door	Dented	2700.00	2700.00
1	Rear LHS door	Damaged	2900.00	2900.00
1	Rear LHS door number plate lamp assy	Damaged	230.00	230.00
1	Rear LHS door black garnish	Distored	180.00	180.00
1	Rear LHS taillamp panel	Dented	1800.00	1800.00
2	Rear LHS airduct garnish @120	Distored	240.00	240.00
1	Rear LHS airduct garnish cover	Missing	210.00	210.00
1	Rear RHS taillamp panel	Dented	1800.00	1800.00
1	Rear RHS airduct garnish cover	Distored	210.00	210.00
4	Rear RHS & LHS door hinge @80	Bented	320.00	320.00
1	Rear LHS door handle cover	Distored	160.00	160.00
2	RHS & LHS rear panel 1 @800	Distored	1600.00	1600.00
2	RHS & LHS rear panel 2 @400	Distored	800.00	800.00

Estimated Amount : S\$43,670
Adjusted Amount : S\$31,300
Estimated Repair Days : 25 days
