**ACCIDENT INVOLVING SLB 8630B & SLM 4643H AT JUNCTION OF BEDOK SOUTH ROAD & NEW UPPER CHANGI ROAD ON 14 MAY 2022 @ 2225HRS**

## **DAMAGED VEHICLE (SLB 8630 B) INSPECTION REPORT (WITHOUT PREJUDICE)**

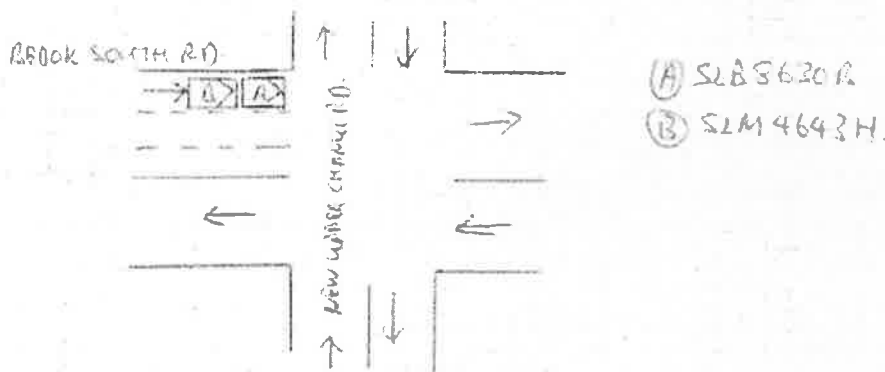
### Sketch Plan

MY CAR WAS STATIONARY DUE TO TRAFFIC LIGHT WAS RED.  
A CAR SLM4643H CAME FROM BEHIND AND HIT INTO MY CAR  
REAR SECTION.

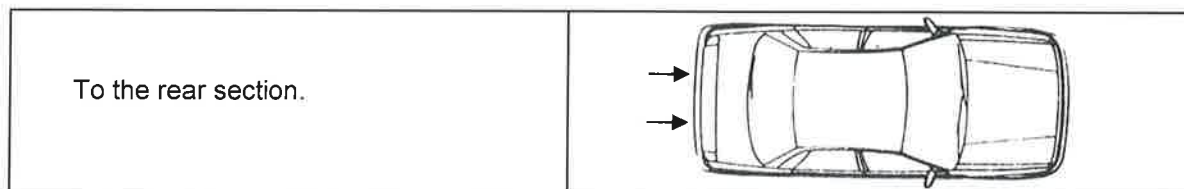
**(E) Point of Impact**

The impact of the collision has damaged/affected the rear bumper, rear bumper parking sensor, rear bumper reinforcement and etc.

Our adjusted cost of lump sum repair is **\$2,800.00** and an estimated **4** days is required to repair the vehicle. Please refer to the Annex for a detailed account of the cost estimates.

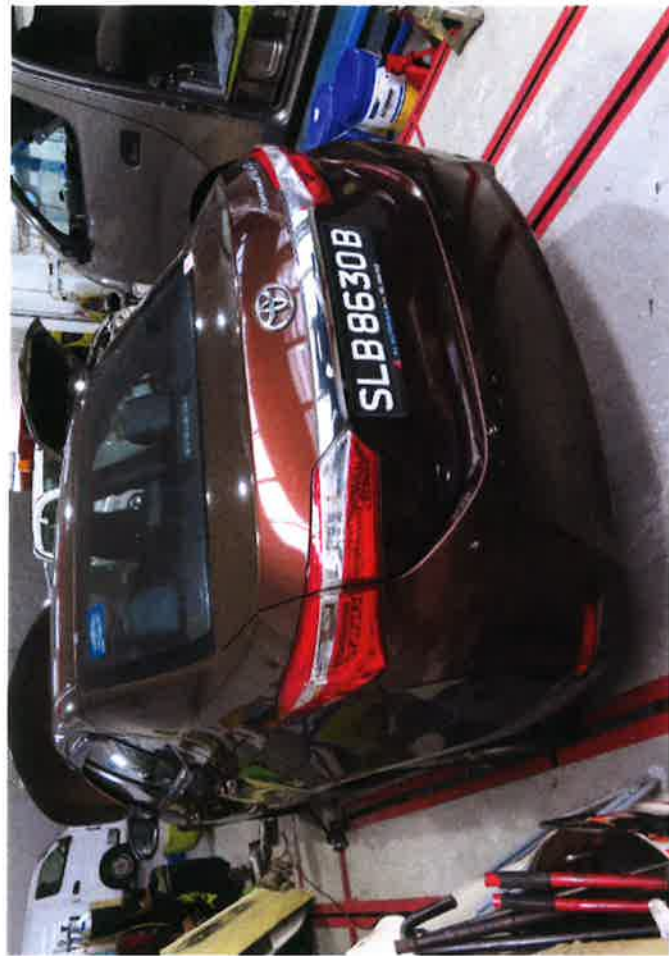
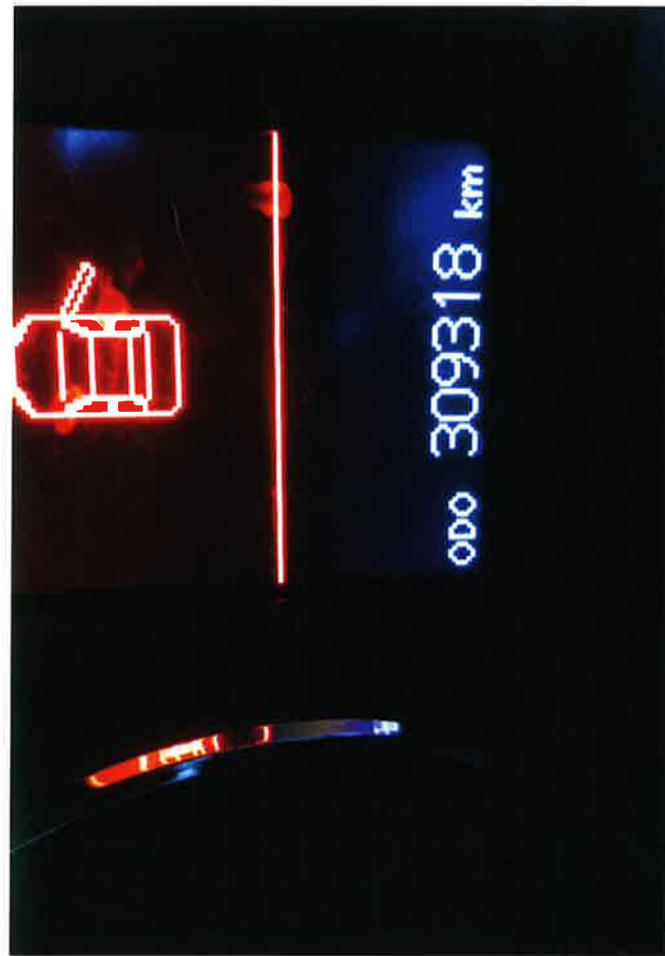
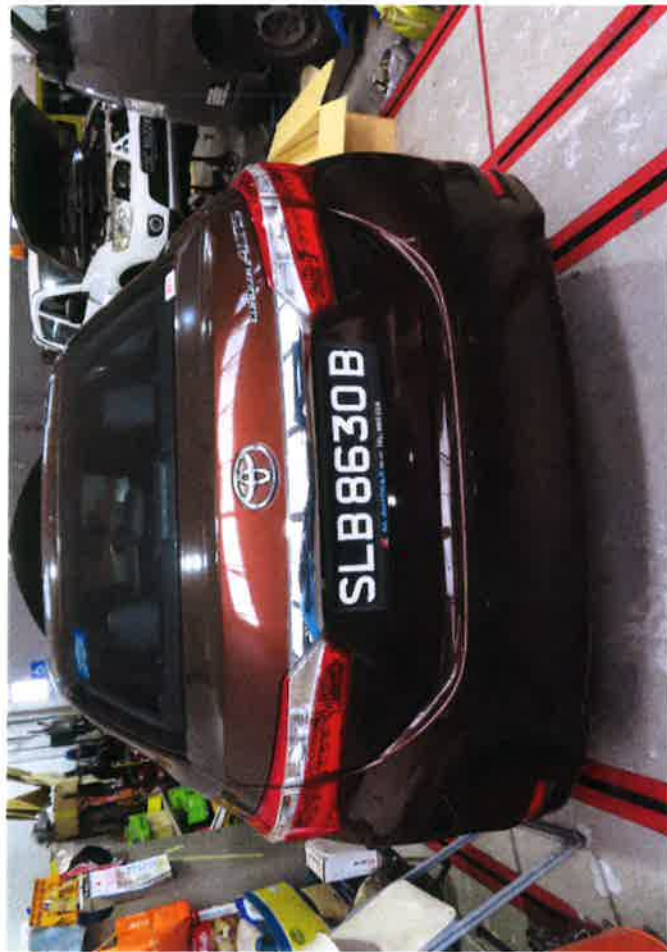
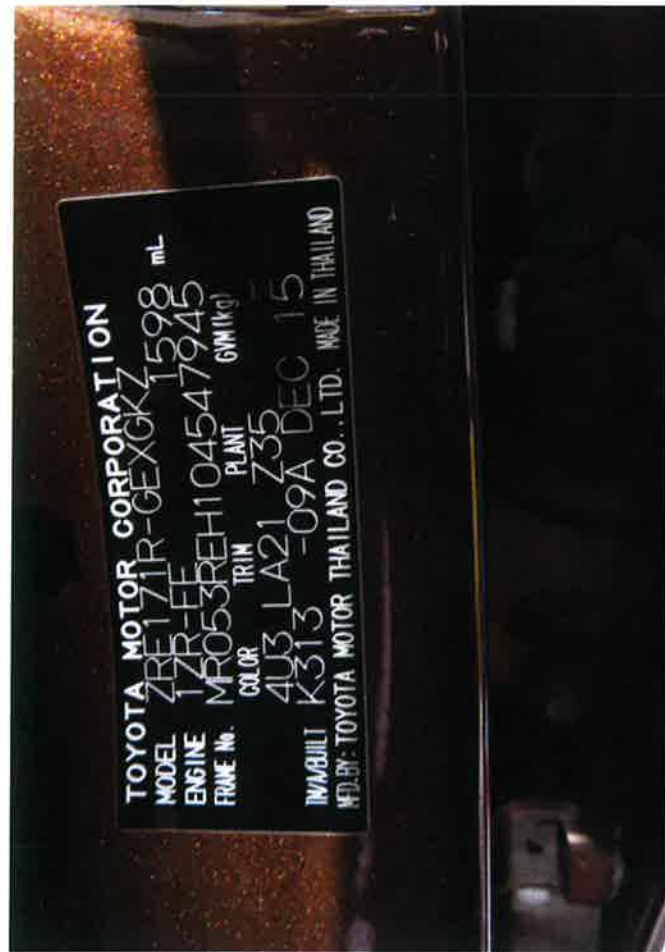
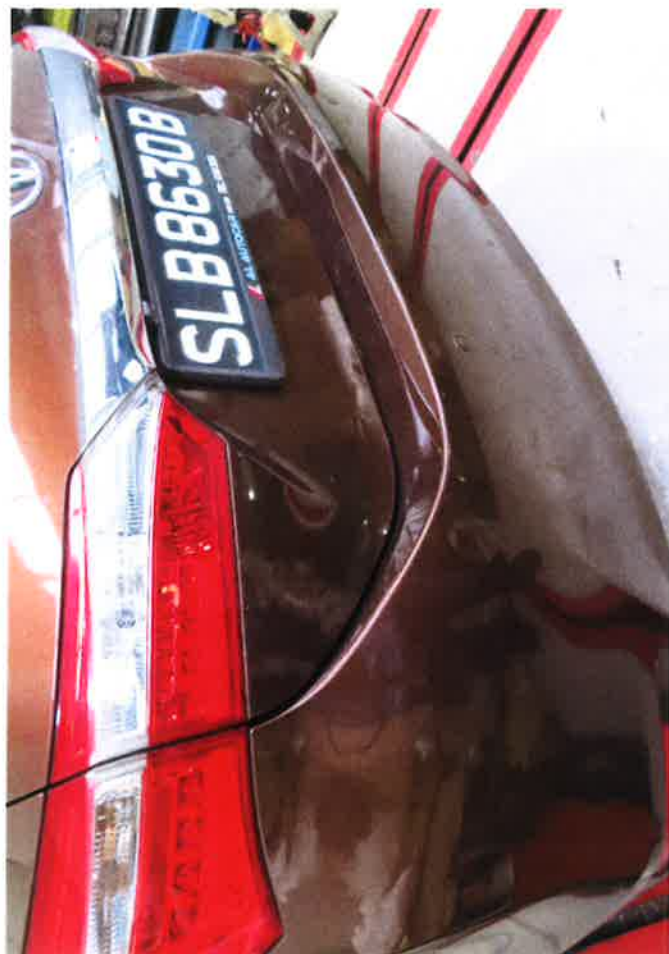
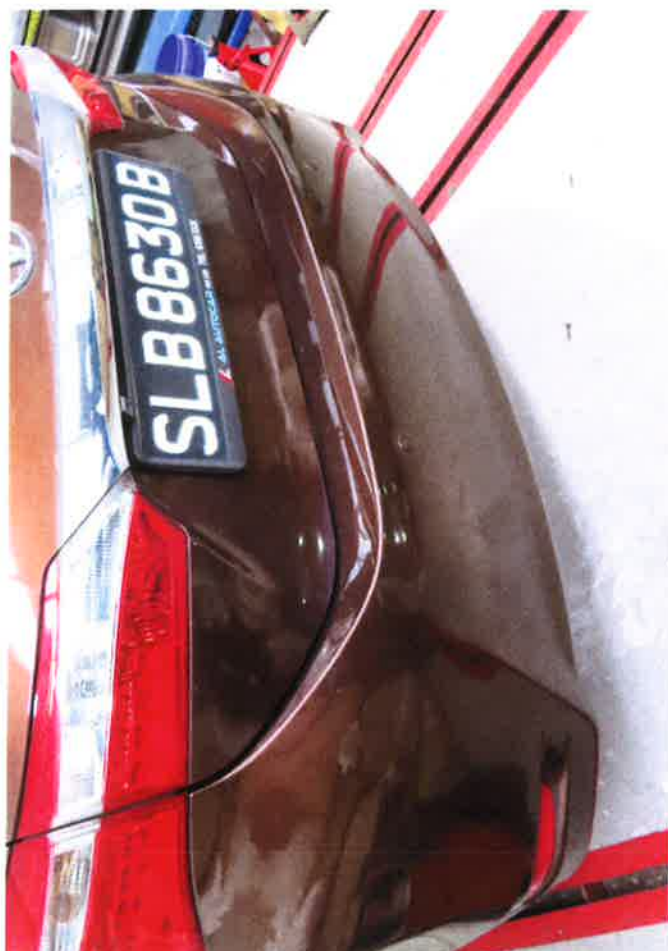
Please refer to the Annex for a detailed account of the damages and photographs taken.
