**WITHOUT PREJUDICE****CLAIM ARISING FROM A ROAD TRAFFIC ACCIDENT ON 20 MAY 2022 AT ABOUT 1630 HRS INVOLVING MOTOR VEHICLES NO(S). SMF8739P AND SHB6620R AND GBG1207D ALONG SLE TOWARDS CITY BEFORE MANDAI**We act for **TEO HONG ANN**, owner of **SMF8739P**.We are instructed by our client to claim damages against you/your insured in connection to the above-mentioned road traffic accident between our client and your/your insured's vehicle **SHB6620R and GBG1207D**.

## VEHICLE INSPECTION REPORT

Registration No : SMF 8739 P

Make / Model : Mazda/ 3

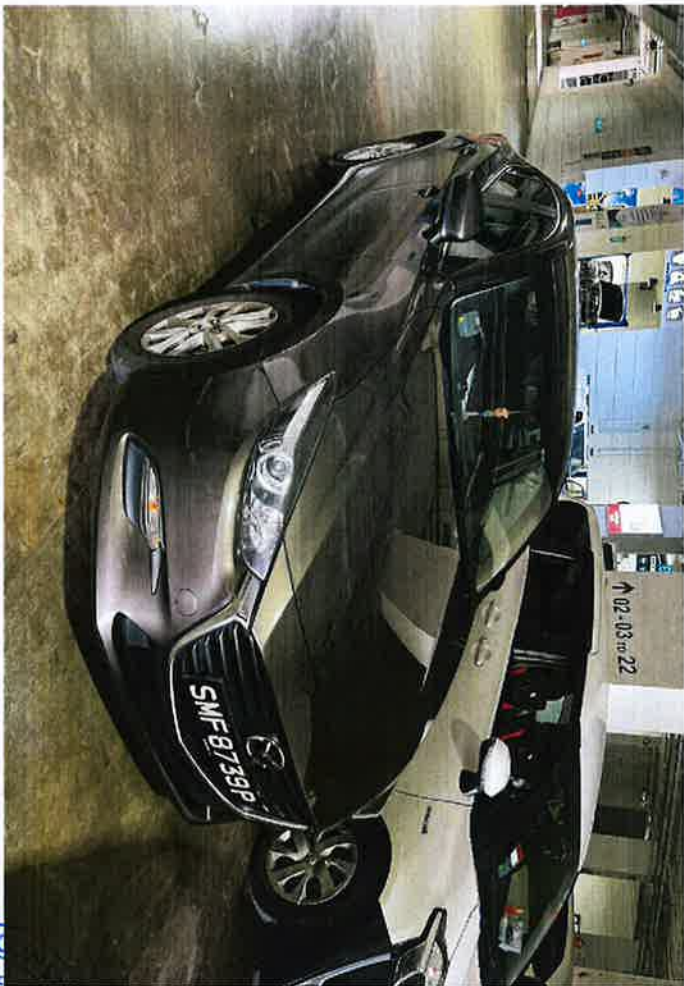
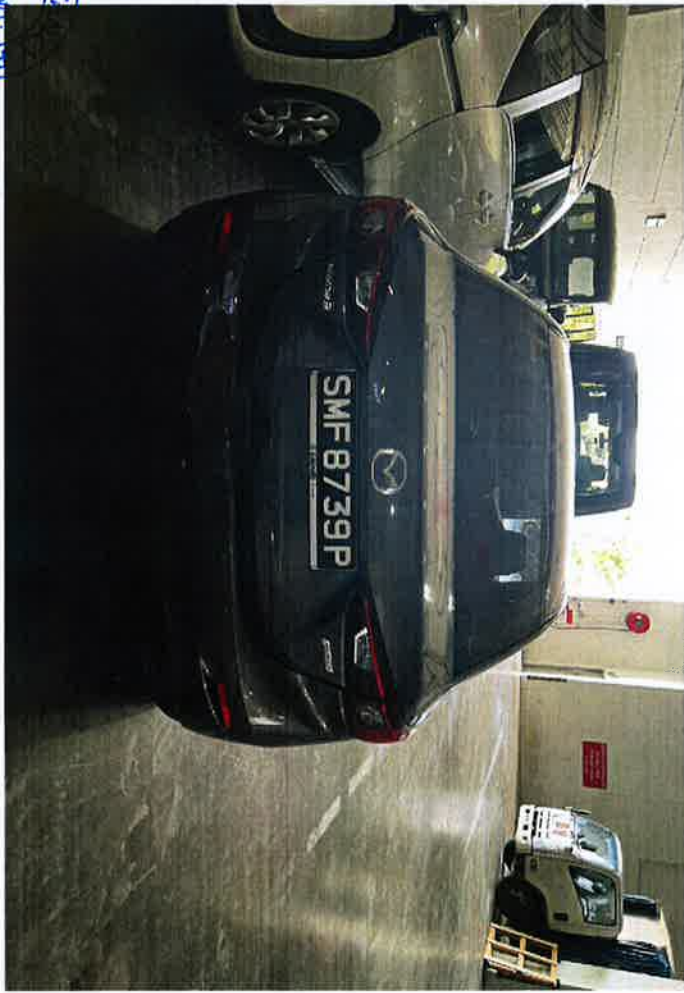
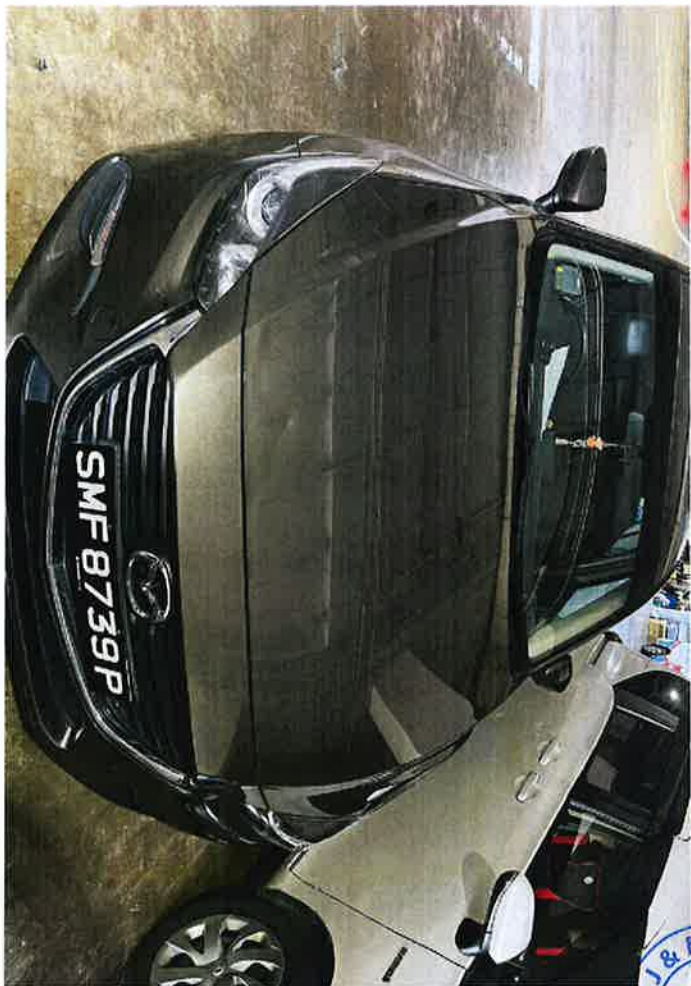
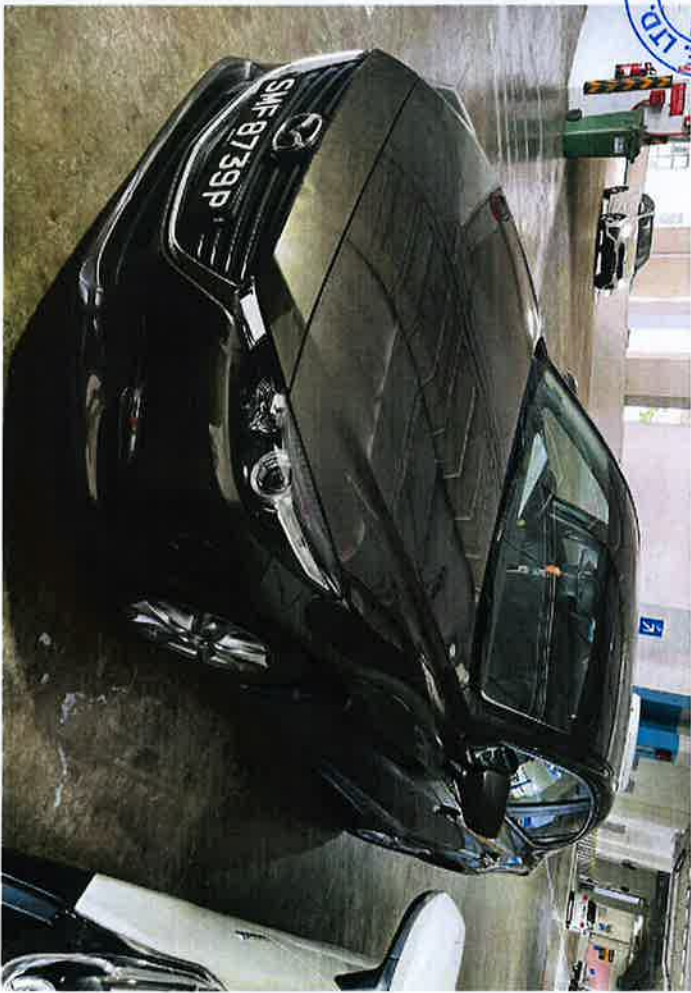
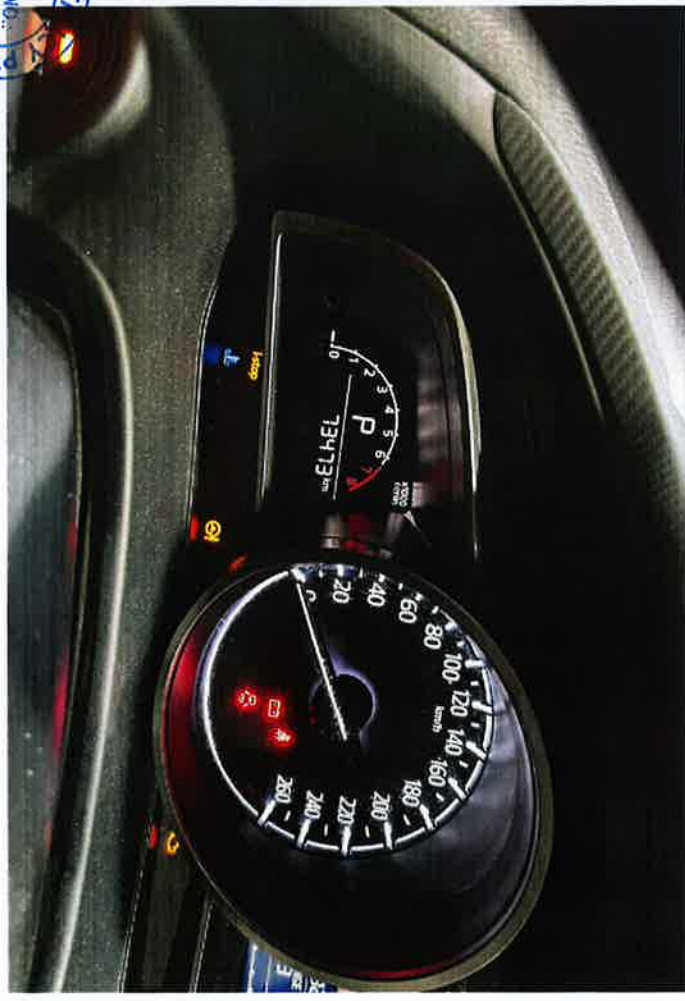
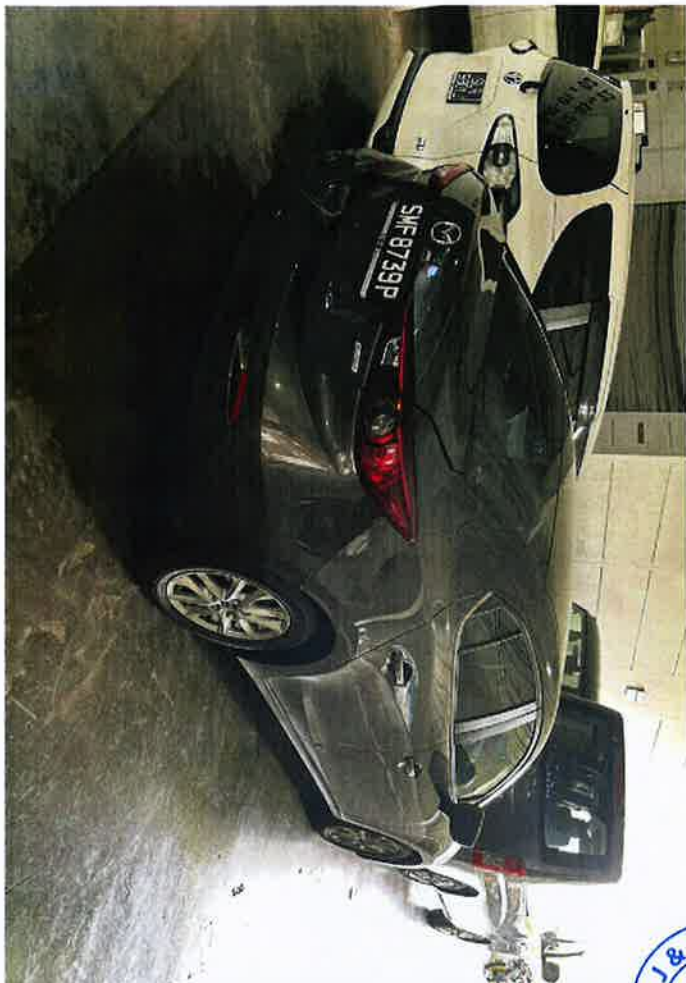
The impact damages sustained on the vehicle at the time of inspection is on the front, rear bumper and tailgate portion.

*(Details refer to the photographs attached)*

Under normal circumstances, the repair period would be about **14 (Fourteen)** working days.

The repairer has agreed to undertake the repair under a Lump Sum Basis. We have further adjusted the amount to a **Lump Sum Repair Contract of : \$ 28,300**
