VEHICLE APPRAISAL REPORT

Registration No.	: SMN 4834G	Chassis Frame No.	: GB7-1092183
Make / Model	: Honda Freed Hybrid 1.5G (A)	Engine No. (Logcard)	: LEB5631252
Year of Manufacture/Reg	: 2019	Odometer Reading	: 271,082 KM
Colour	: Silver		
Class / Type	: MPV

ASSESSMENT SUMMARY

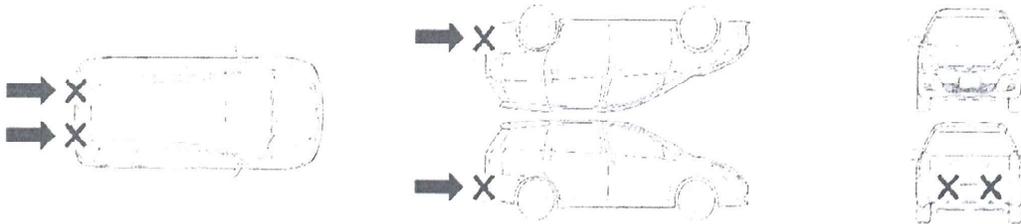
Damages sustained were consistent with the subject vehicle being involved in a collision with another vehicle and the impact was delivered **Squarely to the Rear** portion of the vehicle.

The general area of damages is at the **Rear portion**
 (Please refer to the parts list and photographs as attached for more information)

The estimated repair costs submitted by Messrs **Apex Motoring** is \$ 15,094.00 .
 We have adjusted the cost to \$ 11,759.40 and the repairer has agreed to undertake the repairs at a **Contract Lump Sum of \$ 9,400.00** to a acceptable quality and standards.
