**TRAFFIC ACCIDENT INVOLVING YOUR INSURED'S VEHICLE SH 8096 D AND SFZ 536 M ON 20 JUNE 2022
AT/ALONG THE BKE - CHANGI**

AUTOMAX SURVEY

3. DESCRIPTION OF DAMAGES

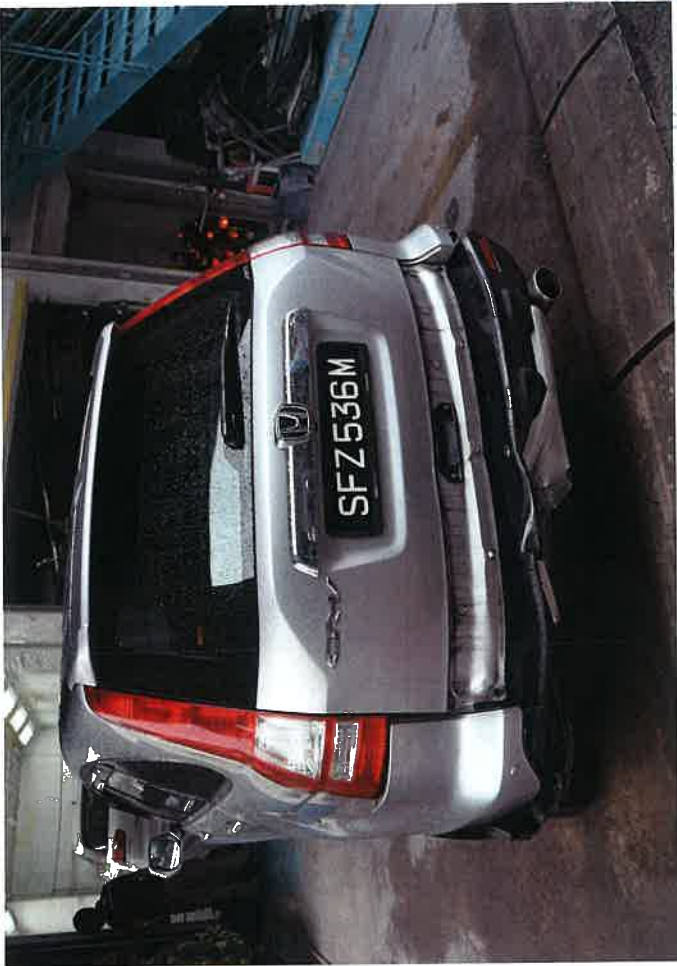
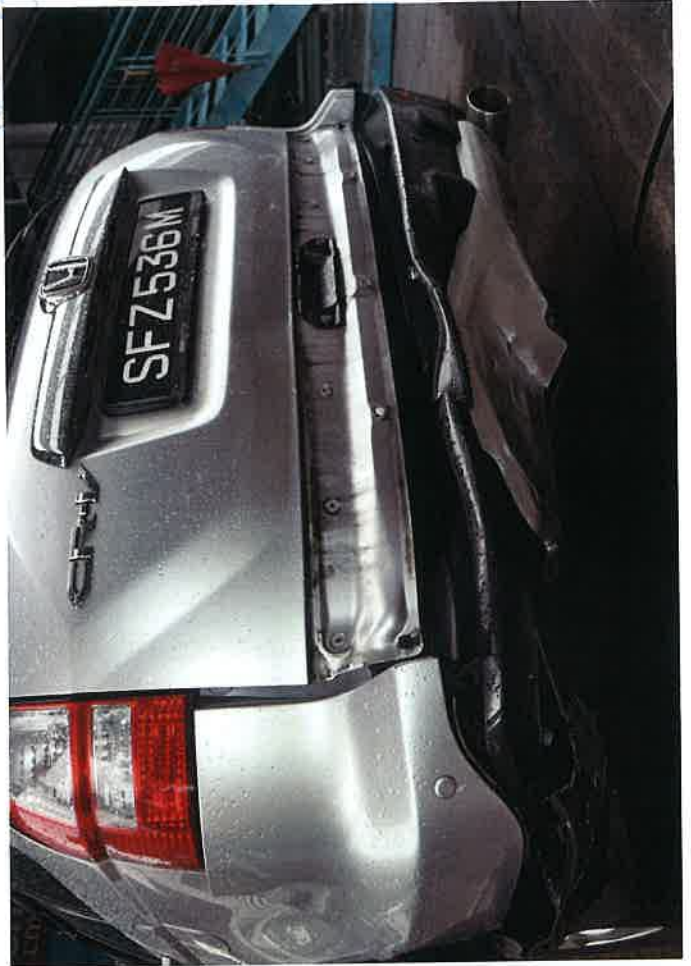
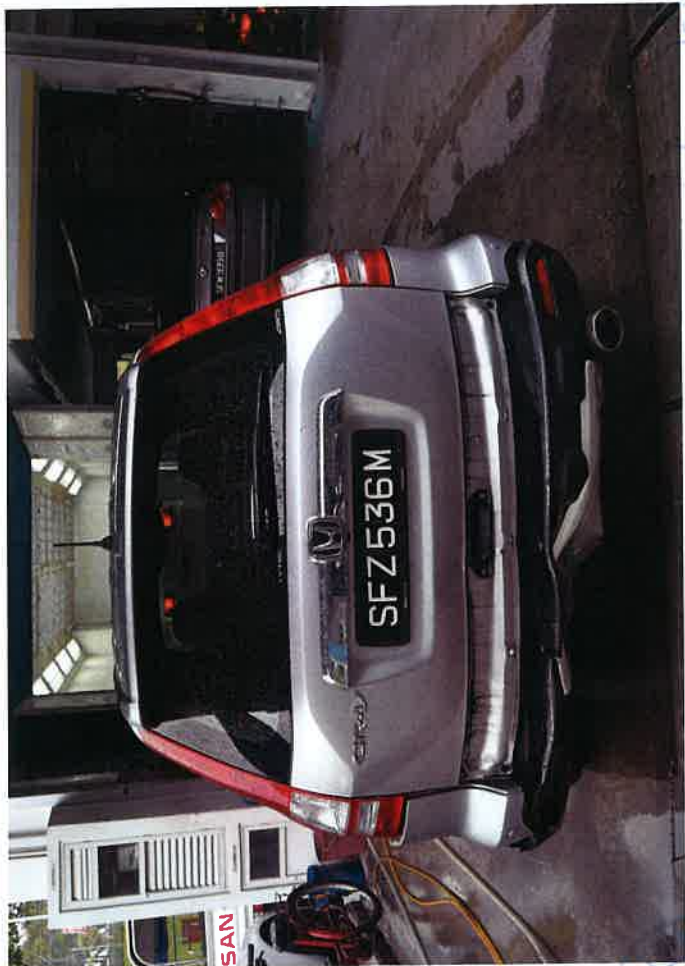
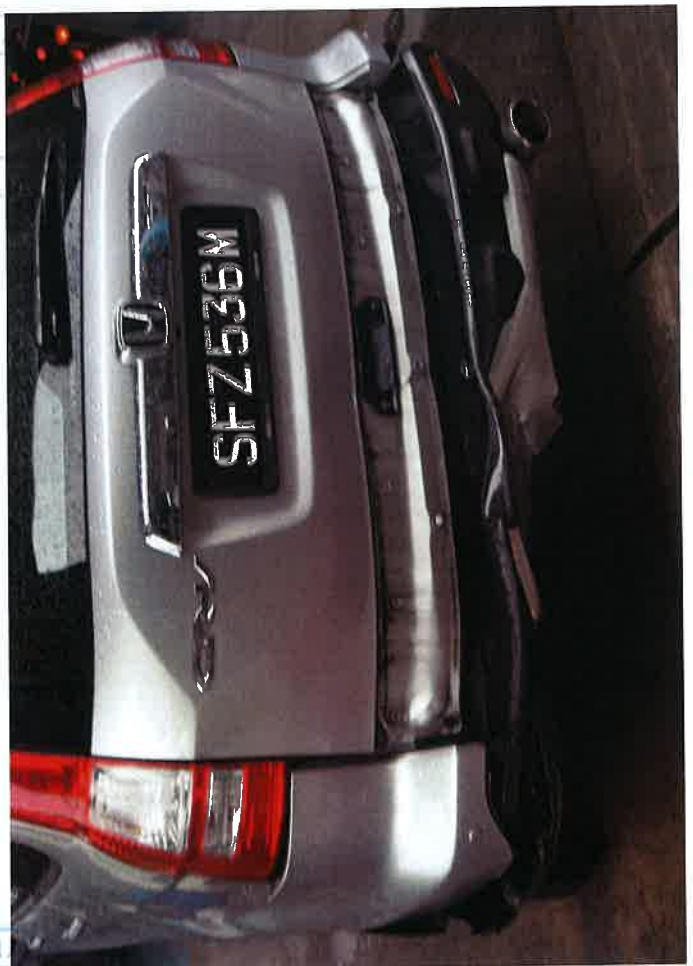
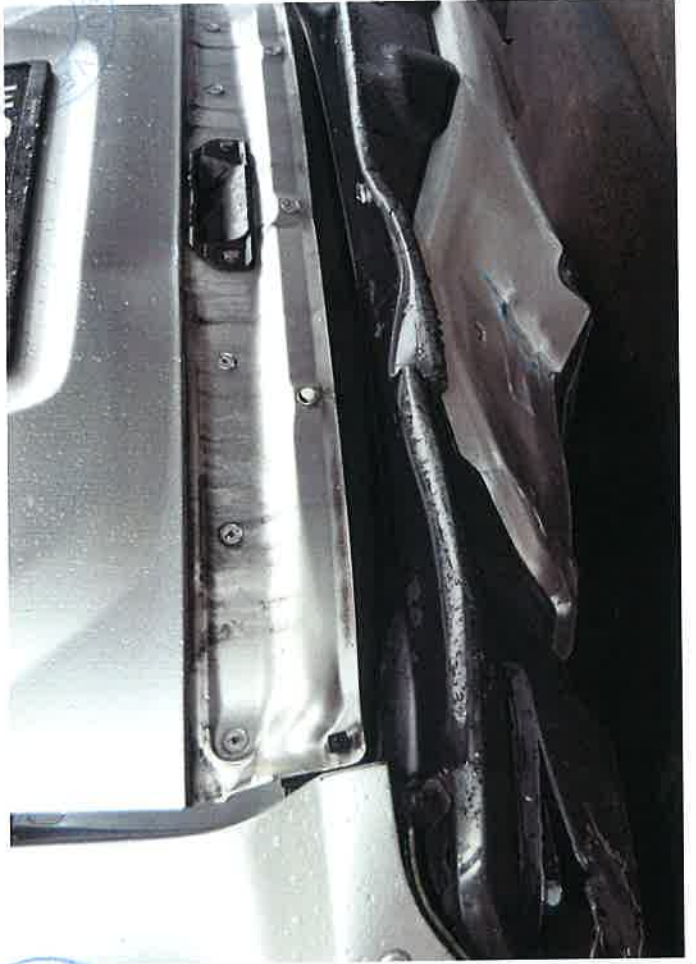
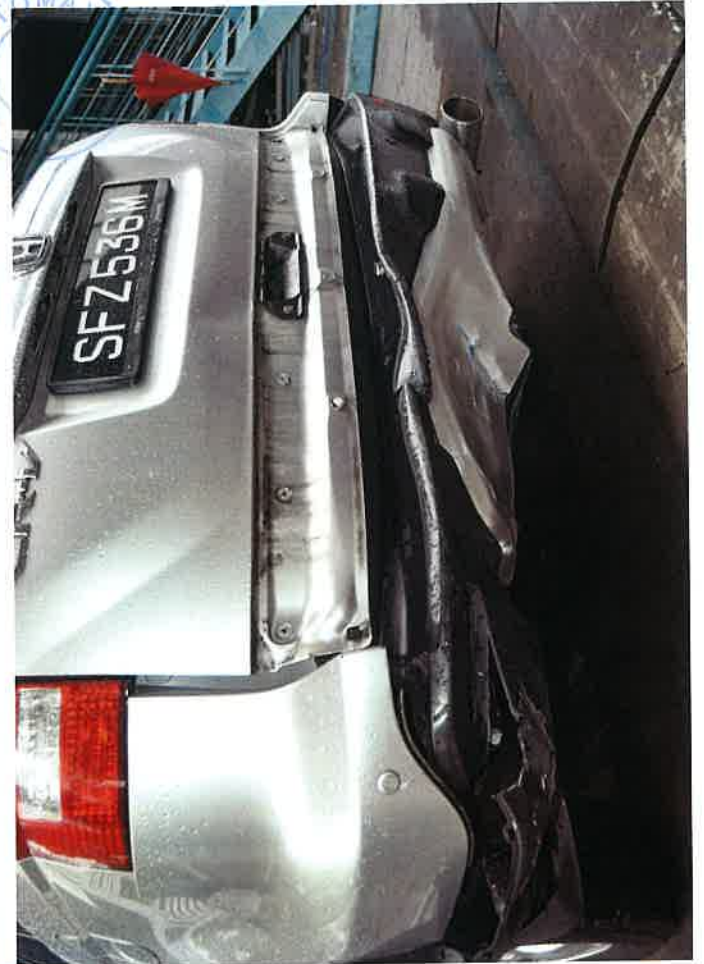
At the time of inspection, we noted that the vehicle has sustained an impact damages on the **Front & rear** portion(s). For more detail of the damages, please see photograph attached.
