4. Description of Damages			
THE VEHICLE SUSTAINED DAMAGES AT THE REAR N/S PORTION. DAMAGES SEE DETAILS.			
5. General Information			
Accident Date	28/06/2023	Inspection Date	10/07/2023
Survey held at	ALAN'S UNITED AUTO PTE LTD BLK 7 SIN MING INDUSTRIAL ESTATE #01-76 SINGAPORE 575642		
5a. Remarks			
A)THE INSPECTION WAS CONDUCTED ON A"WITHOUT PREJUDICE" BASIS. B)IN ACCORDANCE TO YOUR INSTRUCTIONS, WE HAVE NOT AUTHORISED REPAIRS.			
5b. Estimate Days of Repair			
ESTIMATED NORMAL PERIOD FOR REPAIR:		3 Working Days

ADJUSTMENT ON REPAIR COST FOR VEHICLE NO. SGP 75S

PHOTOGRAPHS FOR VEHICLE NO. SGP 75S

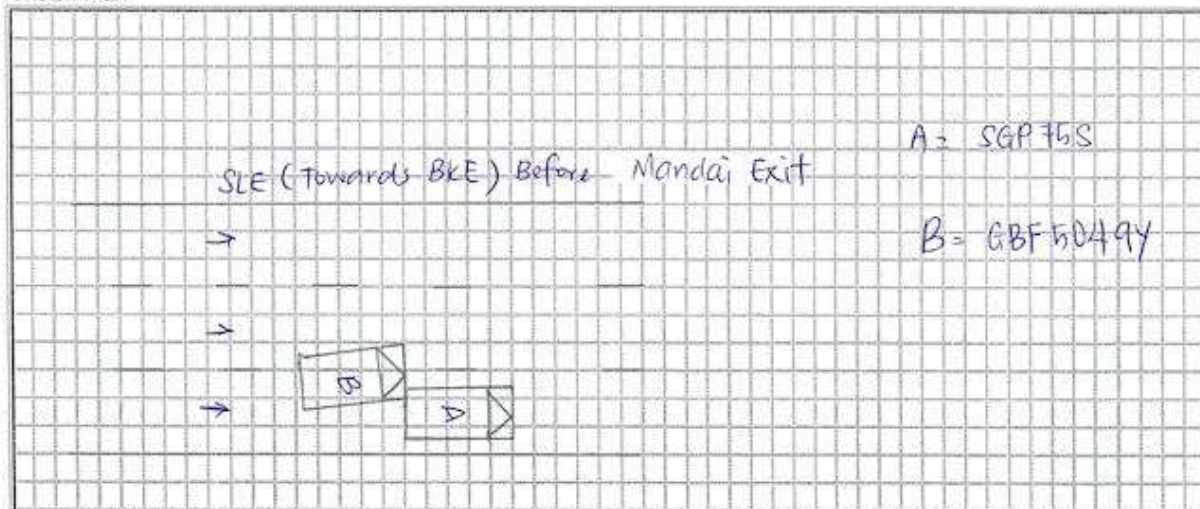
Sketch Plan

At 28 June 2023, around 1719hrs. I was driving toward Woodland Avenue 2 exit whereby I got rear-ended by a Van from the back due to the van being unable to stop. I braked in time to stop, but the van behind failed to do so and swir left to avoid me but still hit the left rear of my vehicle.

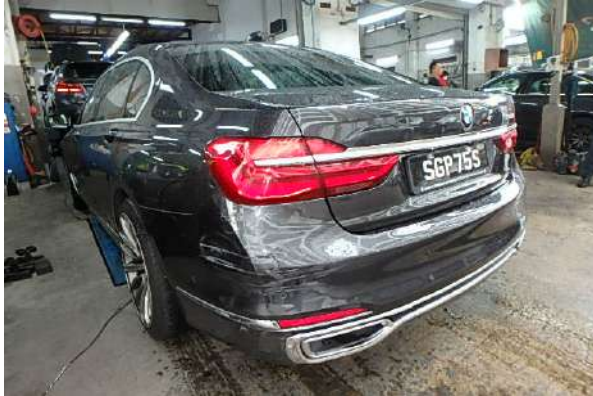
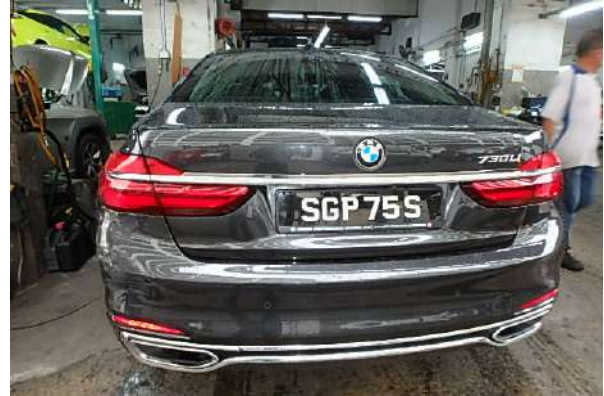
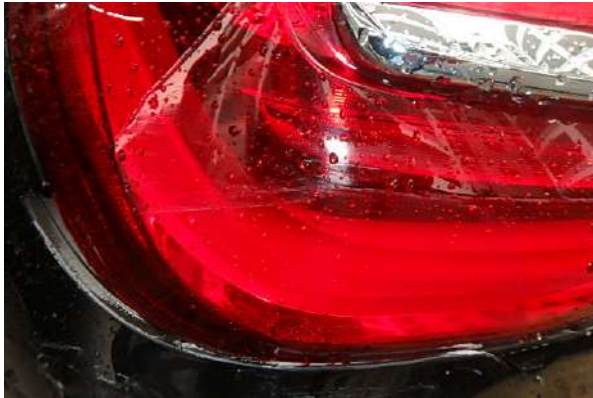
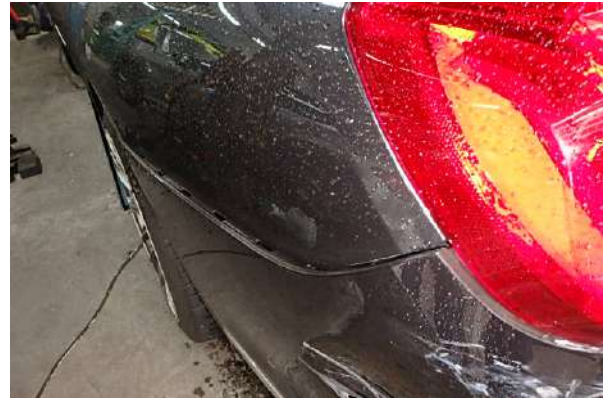
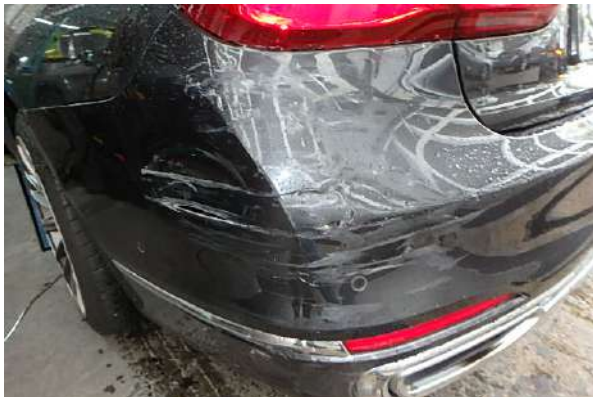
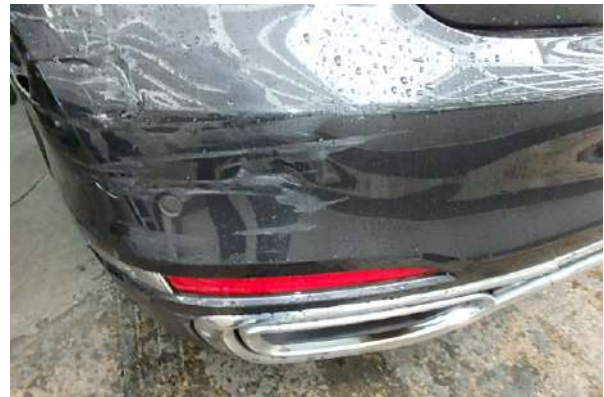
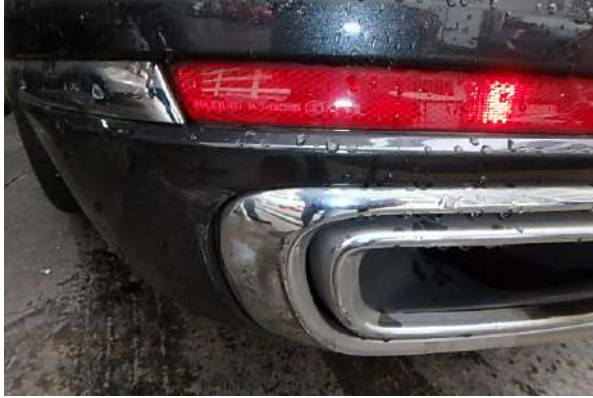
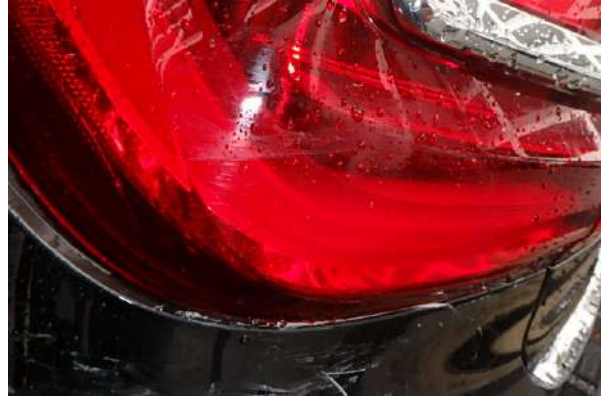
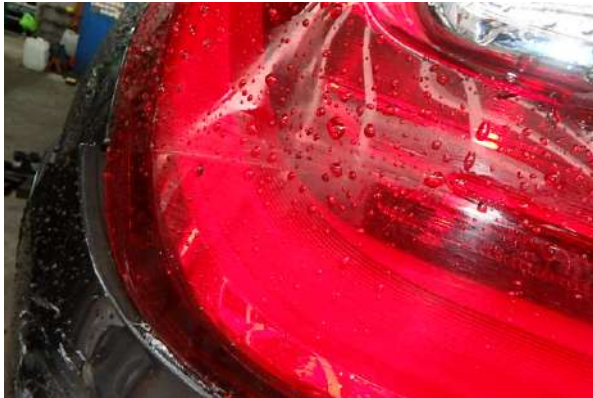
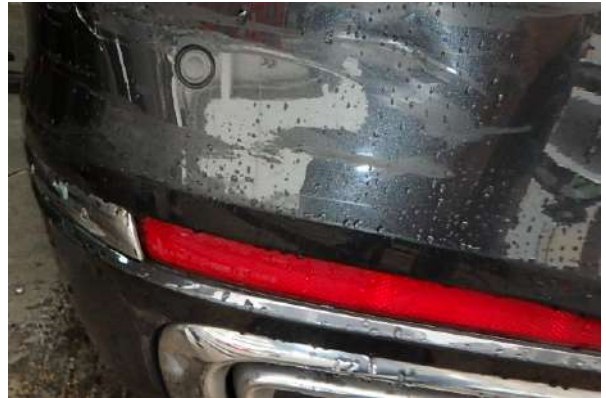
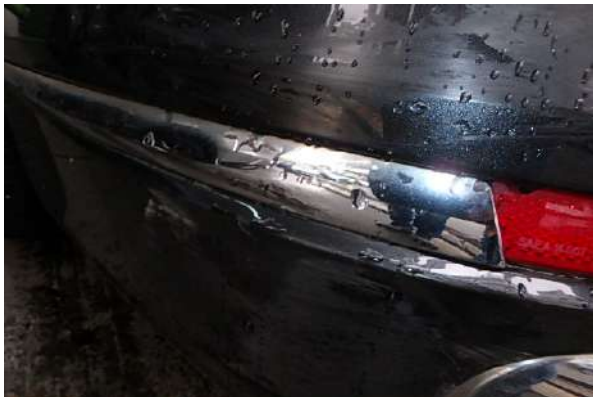
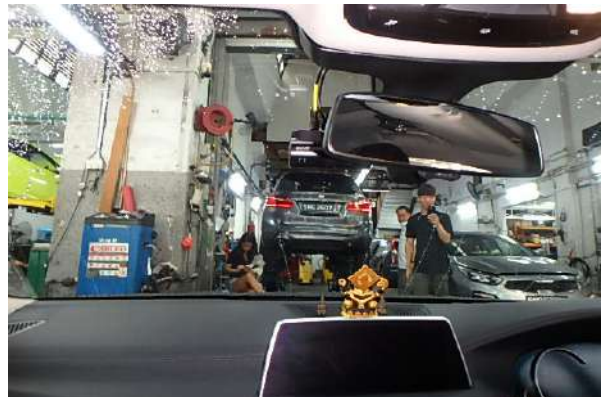
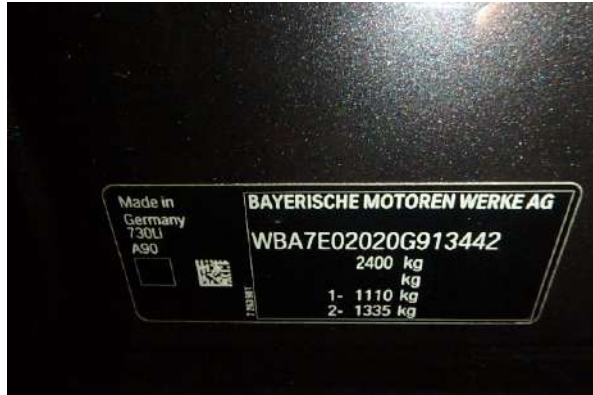
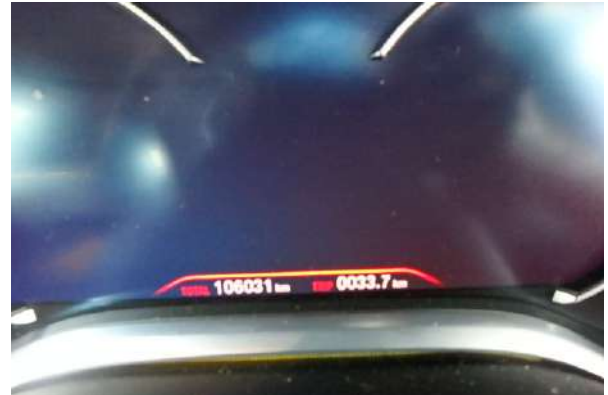
Qty	Description of Parts	Condition	Estimate By Workshop (\$)	Our Adjusted (\$)
	<u>REPLACEMENT OF PARTS</u>			
1	REAR N/S TAILLAMP (WCP)	CUT	900.00	900.00
1	REAR BUMPER FASCIA (WCP)	CRACKED	1,250.00	1,250.00
1	REAR N/S BUMPER SIDE RETAINER (WCP)	DISTORTED	230.00	230.00
2	REAR N/S BUMPER PARKING SENSOR @\$195.00 (WCP)	SHORTED (1PC ONLY)	390.00	195.00
1	RR N/S BUMPER LOWER SIDE CHROM (WCP)	DENTED	180.00	180.00
1	REAR N/S BUMPER REFLECTOR (WCP)	SERVICEABLE	80.00	-
1	REAR BUMPER LOWER CHROME (WCP)	DENTED	180.00	180.00
1	N/S TAILLAMP CENTRE CHROME MOULDING (WCP) (ADDITIONAL)	CRACKED	140.00	140.00
	COST PLUS 10%		335.00	307.50
			3,685.00	3,382.50
	<u>LABOUR</u>			
	TO PUTTY AND SPRAY REPLACED PARTS.		800.00	300.00
	TO REMOVE, CUT-OUT DAMAGED PARTS, PANEL BEATING, WELDING, ALIGN, REFIX AND TO RENEW ABOVE PARTS.		700.00	250.00
			1,500.00	550.00
	GRAND TOTAL		5,185.00	3,932.50
	RECOMMENDED COST OF REPAIRS			3,932.50
