DAMAGE CONSISTENCY AND RE-INSPECTION REPORT

INSURED VEHICLE : YM 4184L as DV (Defendant Vehicle)

THIRD-PARTY VEHICLE : SFL 928P Replaced with SND 918 R as PV
(Plaintiff Vehicle)

DESCRIPTION : TP VEHICLE ALLEGEDLY DAMAGED BY
INSURED'S TOW TRUCK

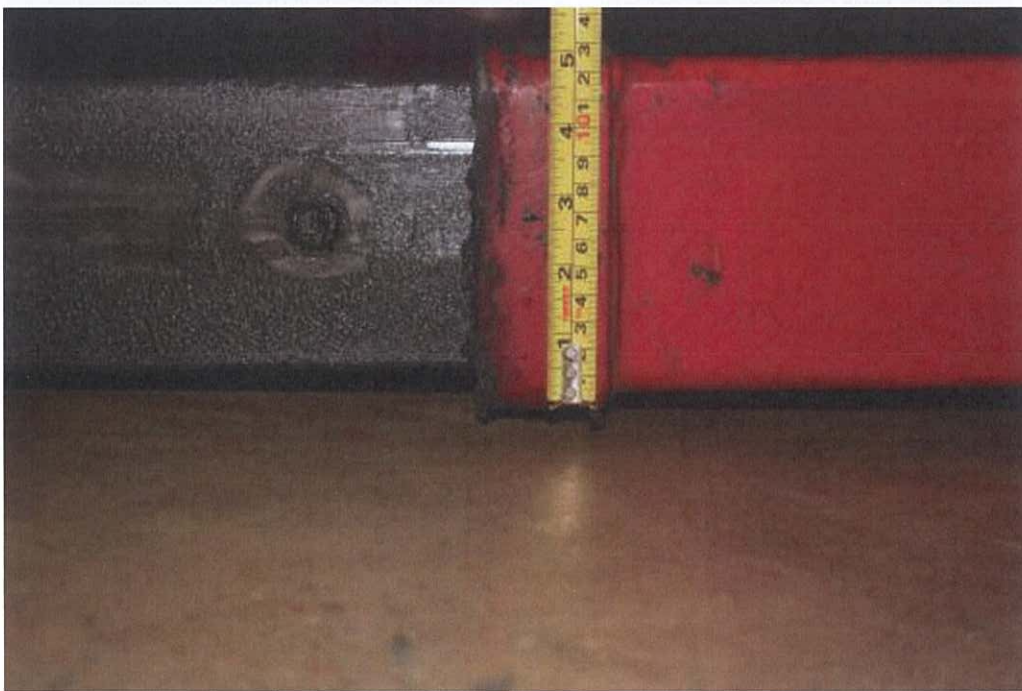
Photo 5 - Measurement on the Tow Truck lifting boom housing height reads 12.5cm

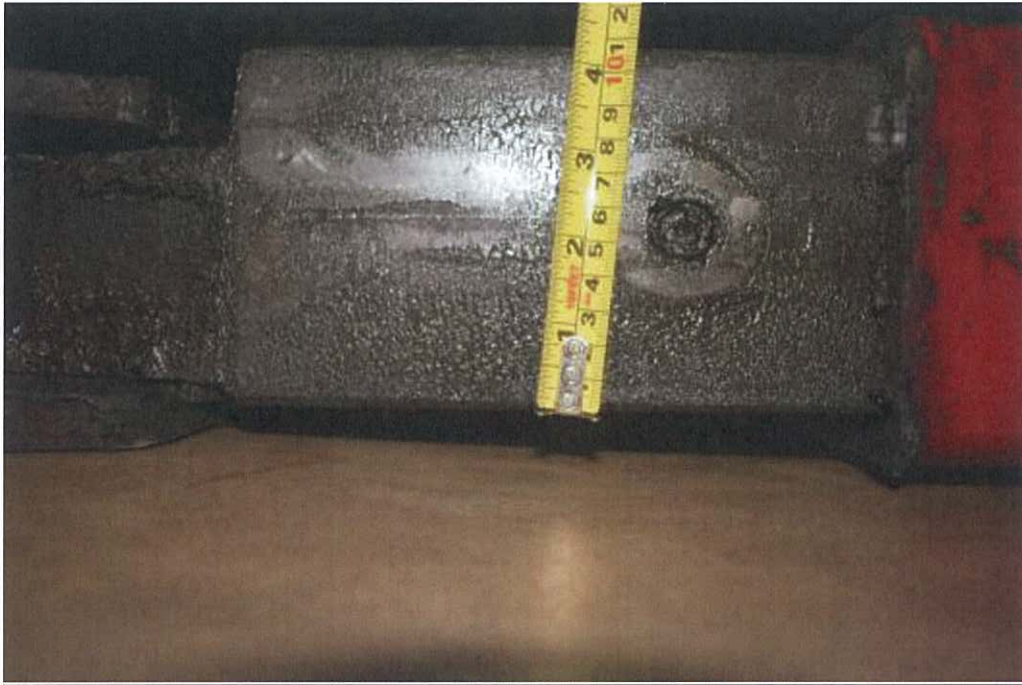
Photo 8 - Measurement on the Tow Truck lifting Inner Boom height reads 10.9cm

- (1) From the damage pattern to the Rear Exhaust Muffler of PV, it appears that the dent mark was caused by Tow Truck's Inner Boom. The measurements on the Rear Muffler dent matches with DV Tow Truck lifting Inner Boom. The damage to the Rear Muffler is due to a centered single impact which suggested it could be damaged during the descending and unloading process of DV vehicle. From our understanding, before PV is being lowered onto the ground level, wooden blocks should be used to support both the tyres of PV ensuring the height of PV is being lifted to allow the lifting boom to retract safely into the boom housing. As DV lifting inner boom's Fork can be swivel freely, we rule out damage to PV exhaust muffler caused during the towing process to Carros Centre. As also mentioned in LKK's report (Pg 9 Para 25) No Overlapping Indentation in a single impact and upward impact direction. If it was damaged enroute to Carros, as DV was in motion and the tow boom swivel, damage sustained to the Exhaust Muffler would be multiple dents, cuts, and scratches. Therefore, this is ruled out.

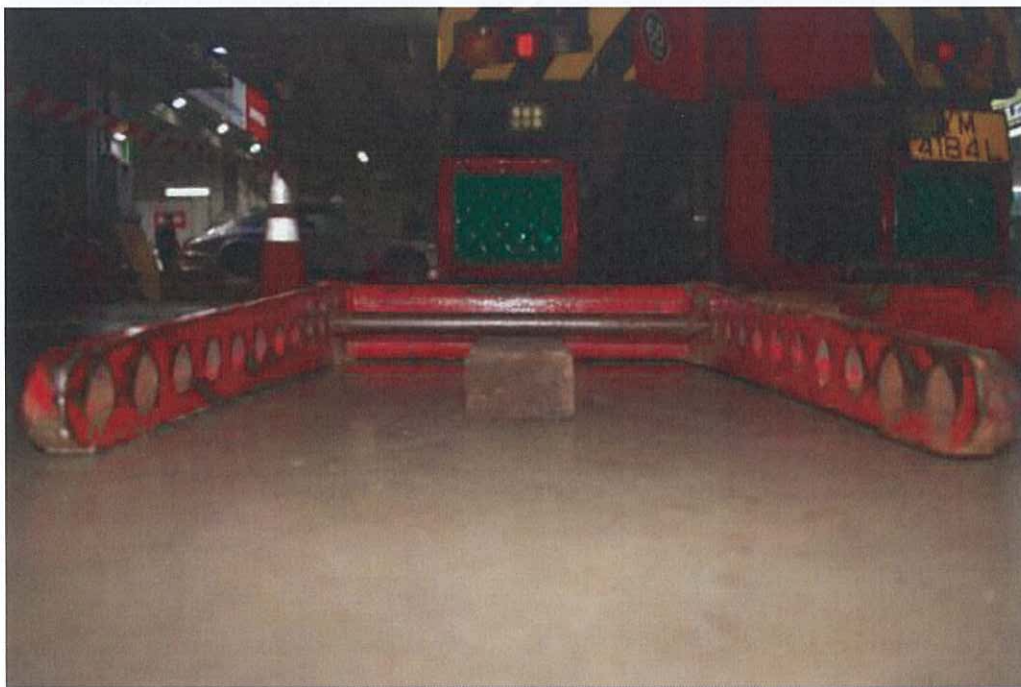
Photo 17 – The proper way to unload a low floor clearance vehicle by using 2 wooden blocks in between each fork

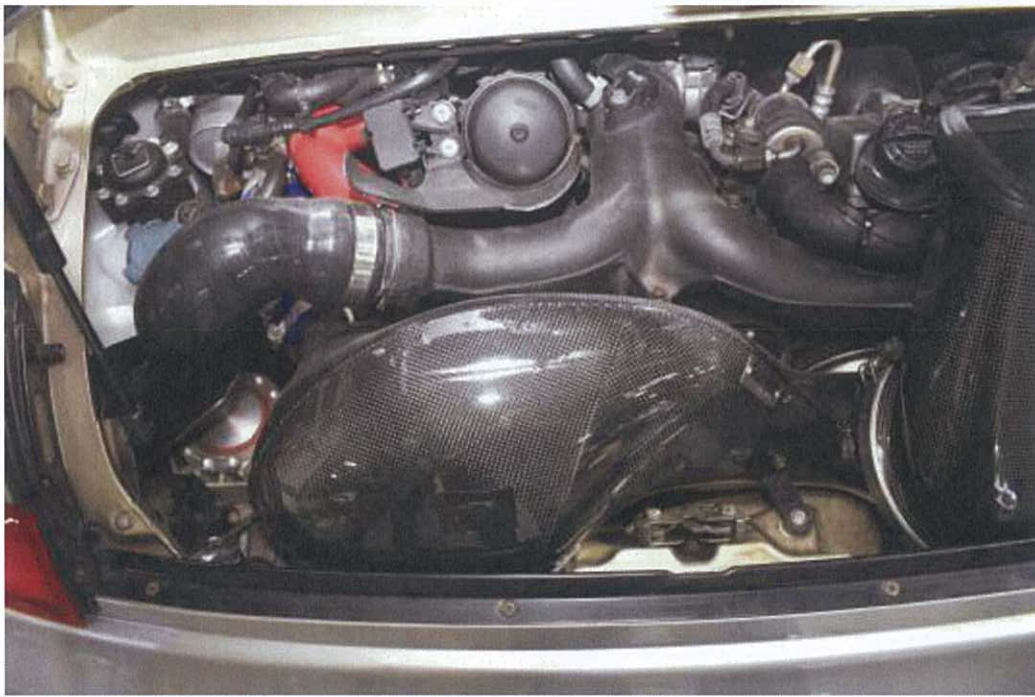
Photo 20 – General View of the Air Duct

- (8) Page 19 & 20 of LKK's report photos 26,27 & 28 show the airduct suffered **semi-circular cut marks** by a mechanical rotating part, a pulley. We also **Do Not Agree** it was caused and/or related to this incident. The entire duration of the towing operation till the destination, the engine of PV was not in operation and therefore the pulley could not move. It is not consistent to this incident. During our physical survey we understand this airduct is tightly secured by screws, hose clips and metal brackets which in our opinion, it could not have shifted or suffered any movement due to this incident.

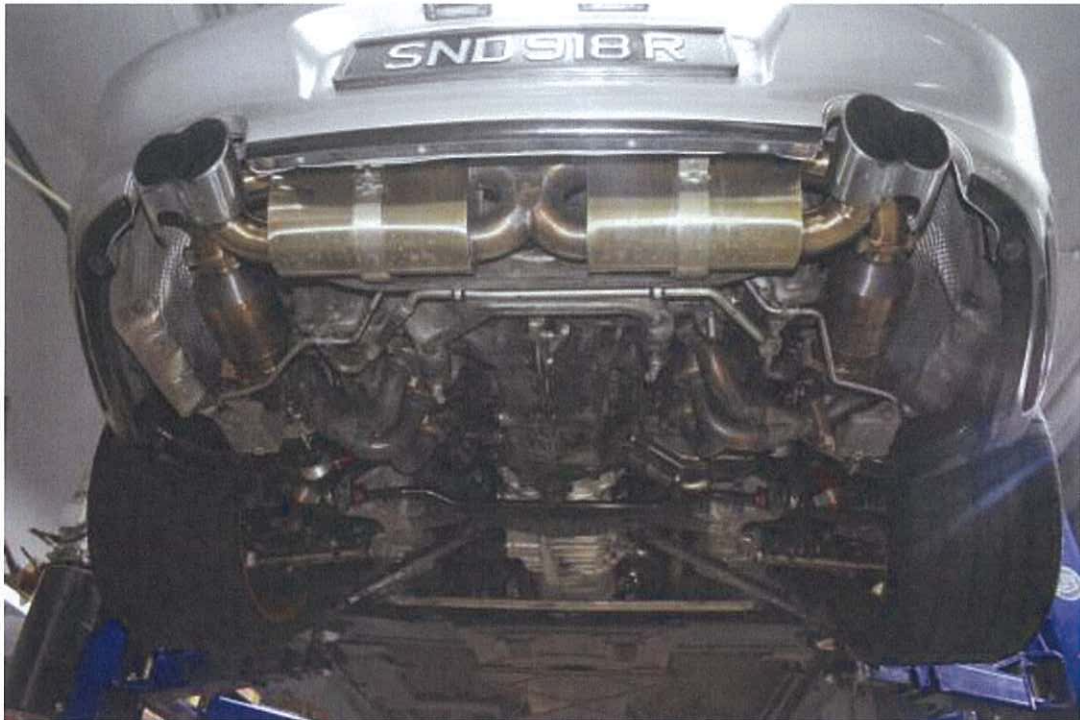
Photo 23 - PV hoisted up for survey inspection

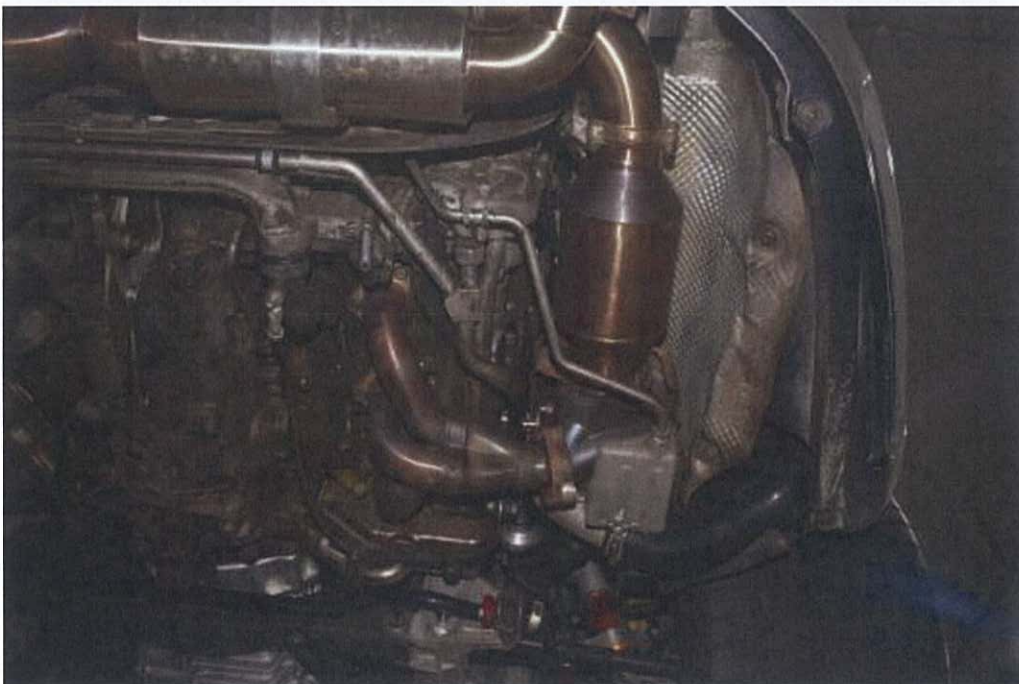
Photo 24 – PV Right Exhaust

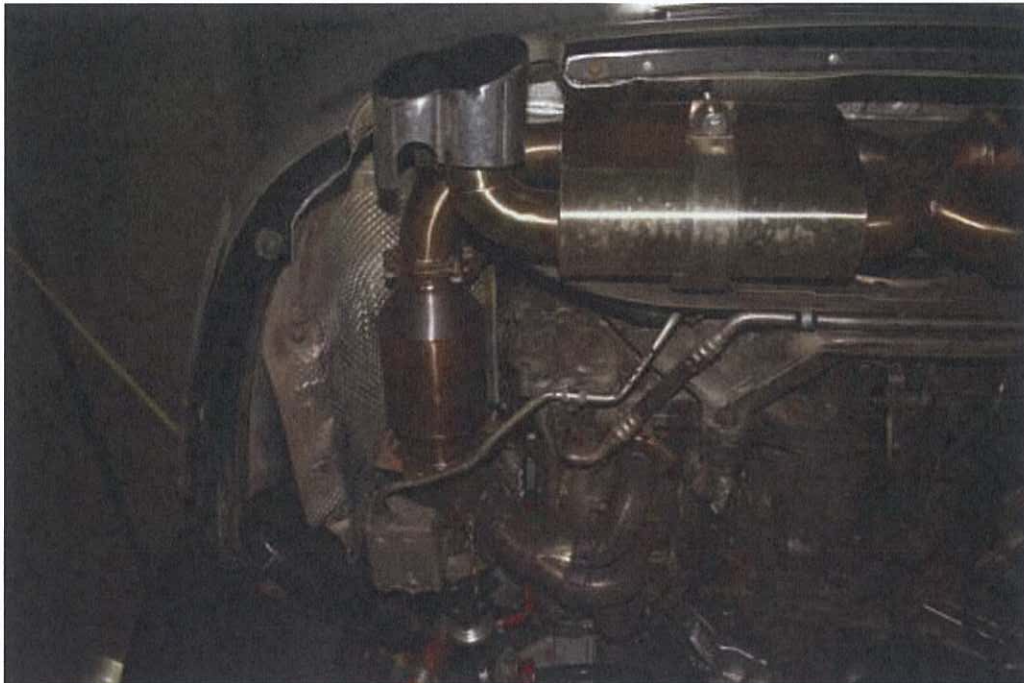
Photo 25- PV Left Exhaust

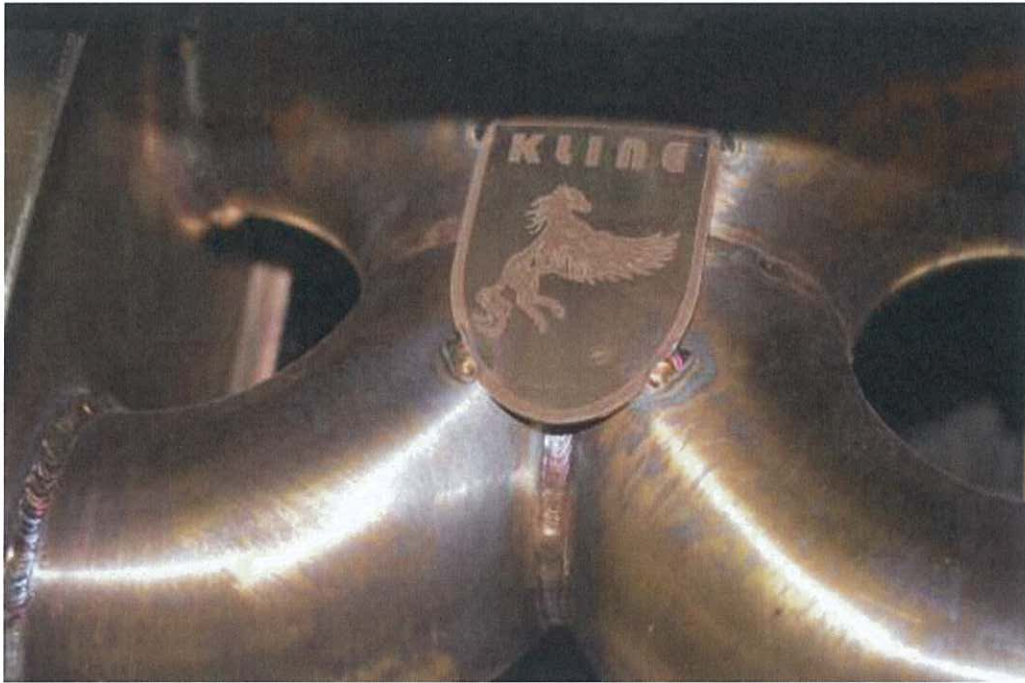
Photo 27 – PV installed with Kline Innovation Exhaust System

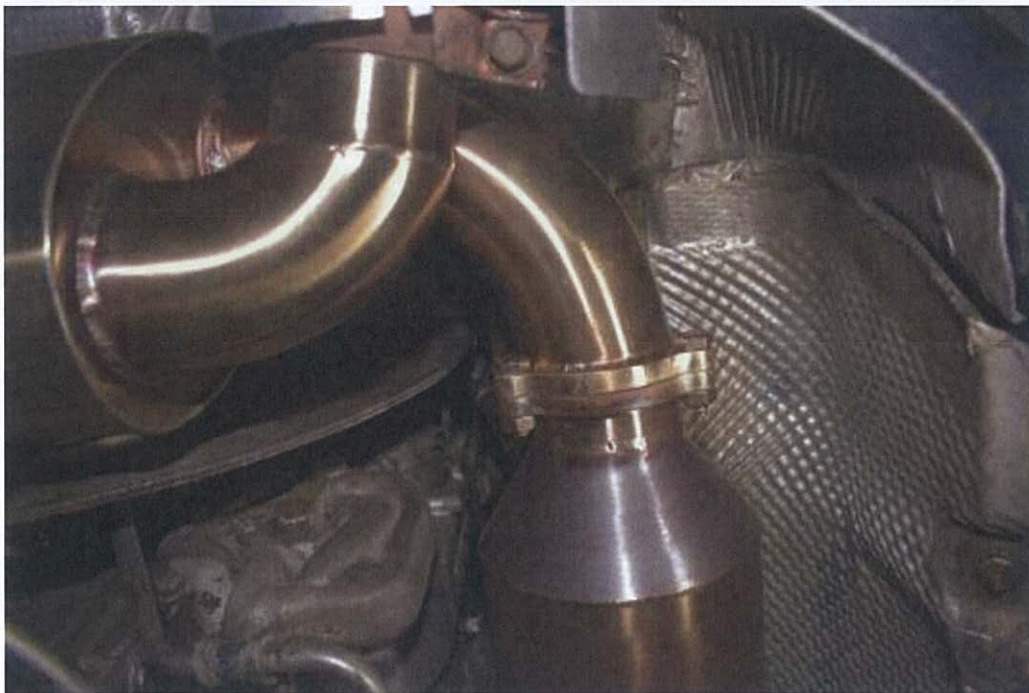
Photo 28 – PV Right Exhaust Muffler to Catalytic Converter

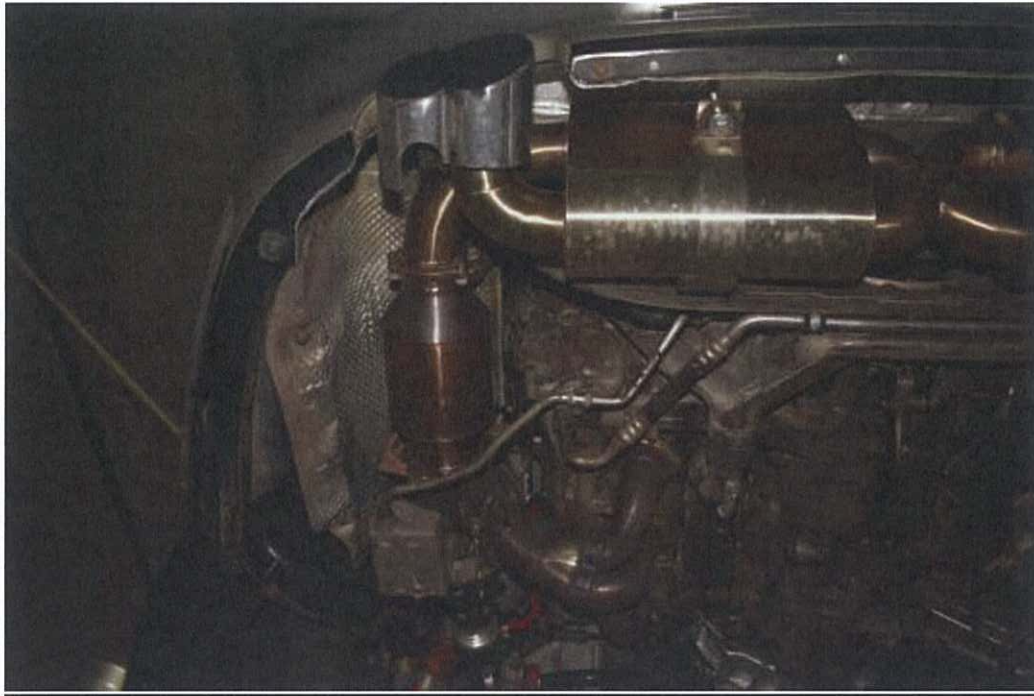
Photo 31 – PV Left Exhaust Muffler to Catalytic Converter

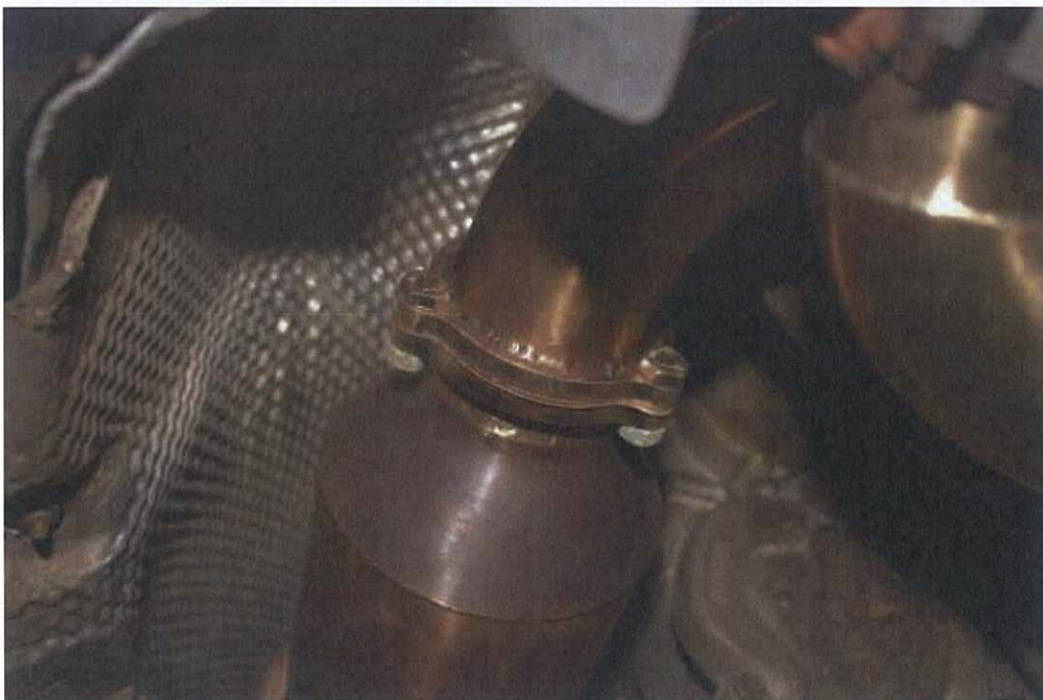
Photo 32 – PV Left Exhaust Muffler to Catalytic Converter Joint

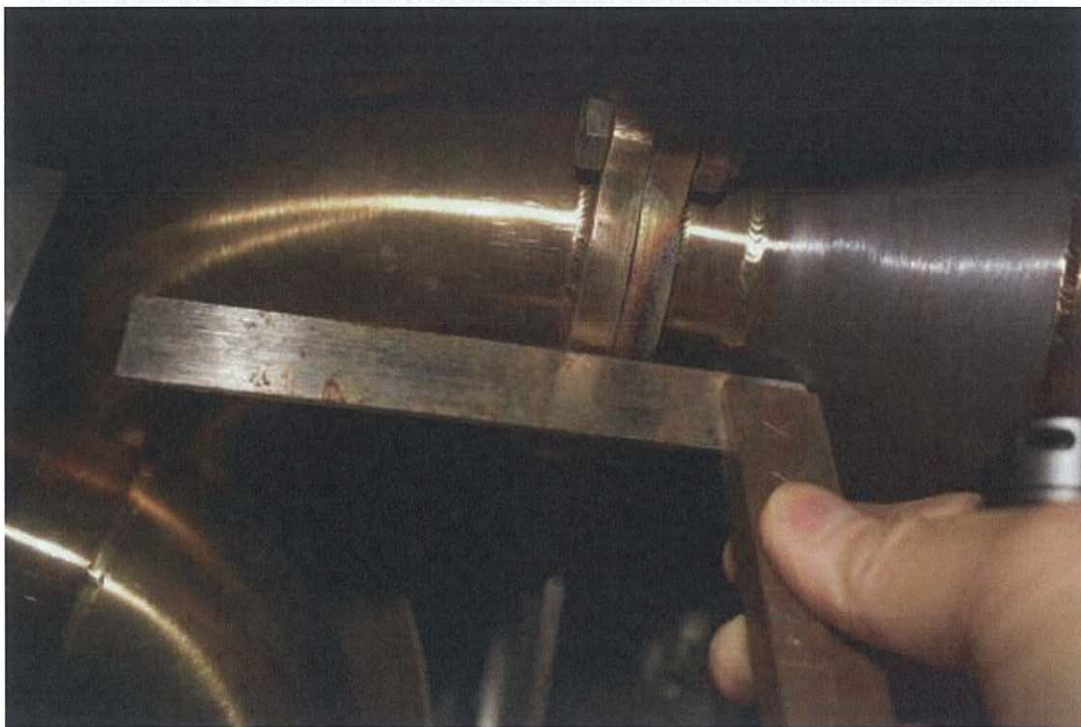
Photo 34 – Measuring the Joint of the right Exhaust Muffler to Catalytic Converter

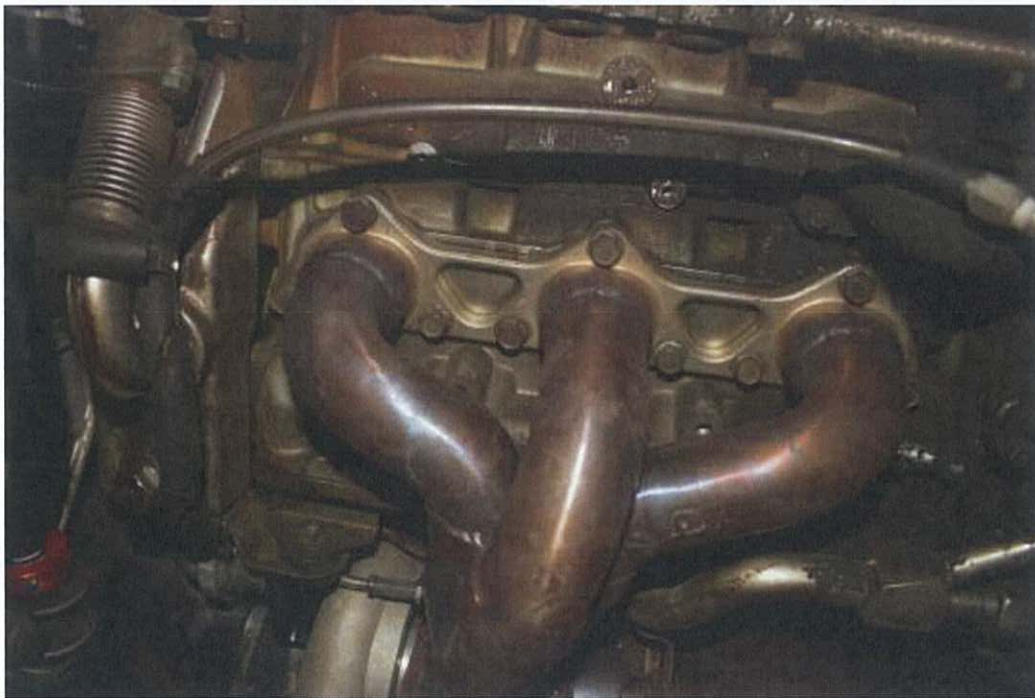
Photo 36 – Right Exhaust Manifold

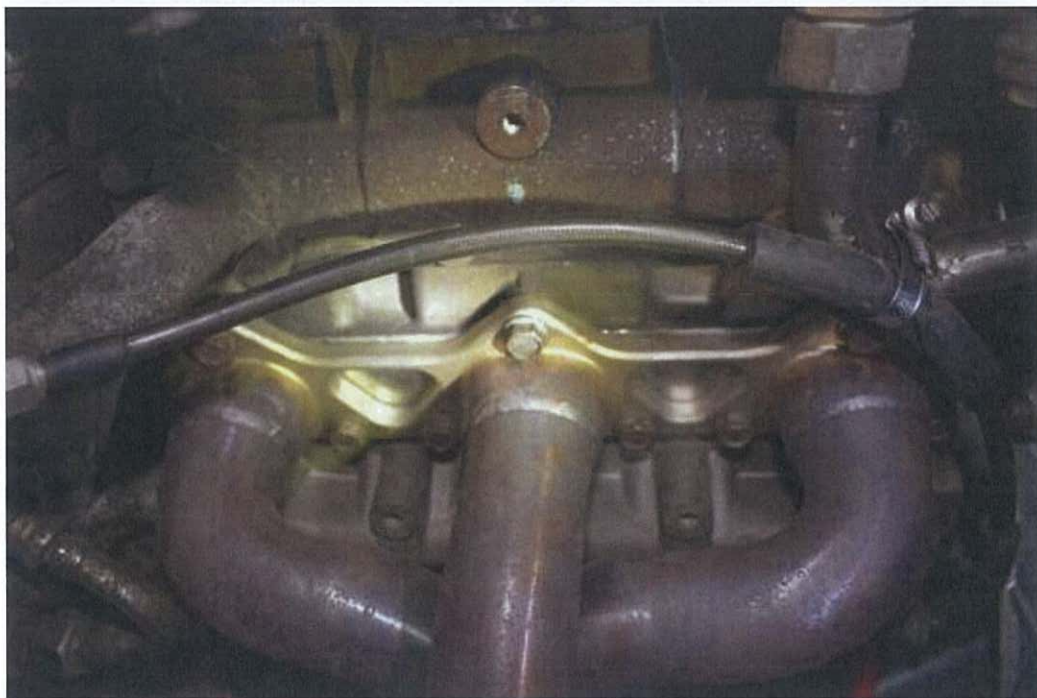
Photo 44 – Left Exhaust Manifold

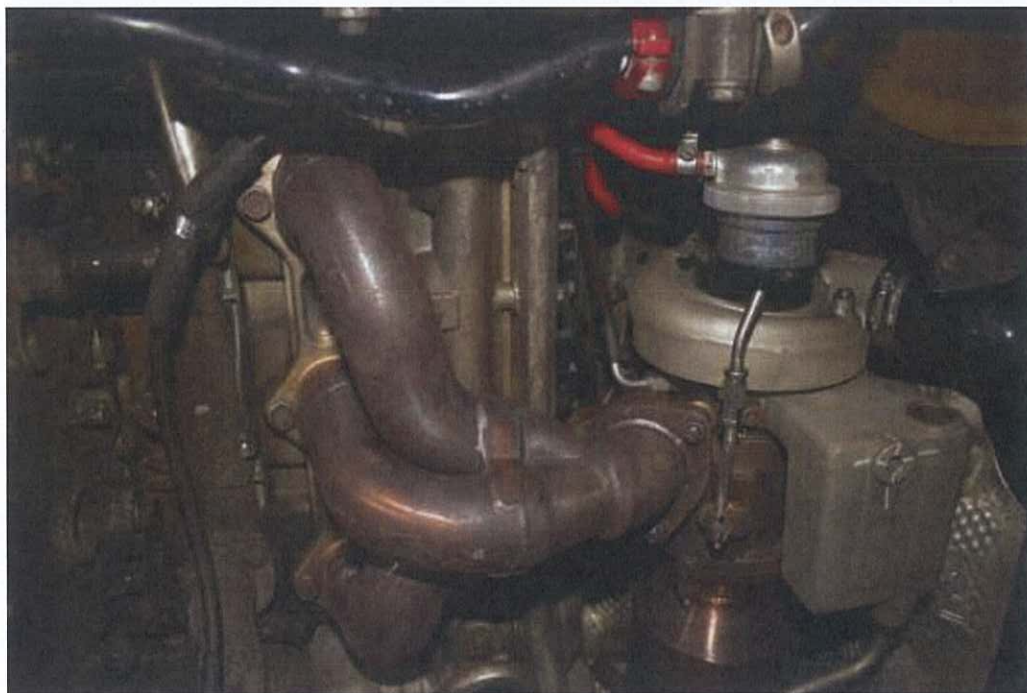
Photo 48 – Left Exhaust Manifold and Turbo

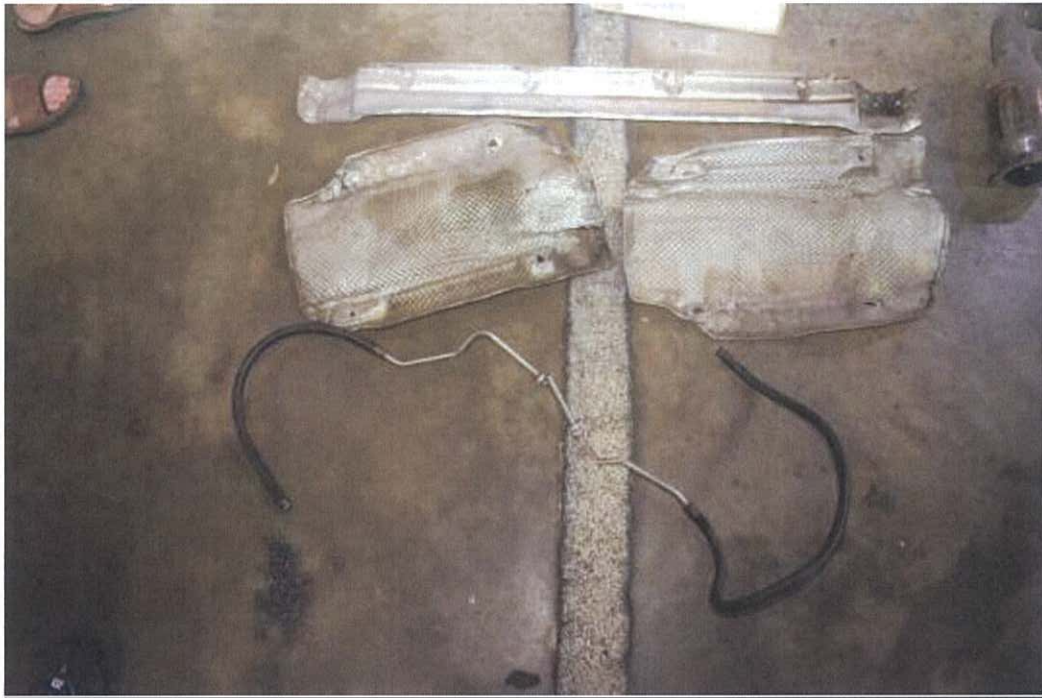
Photo 53– Old parts retained for our survey

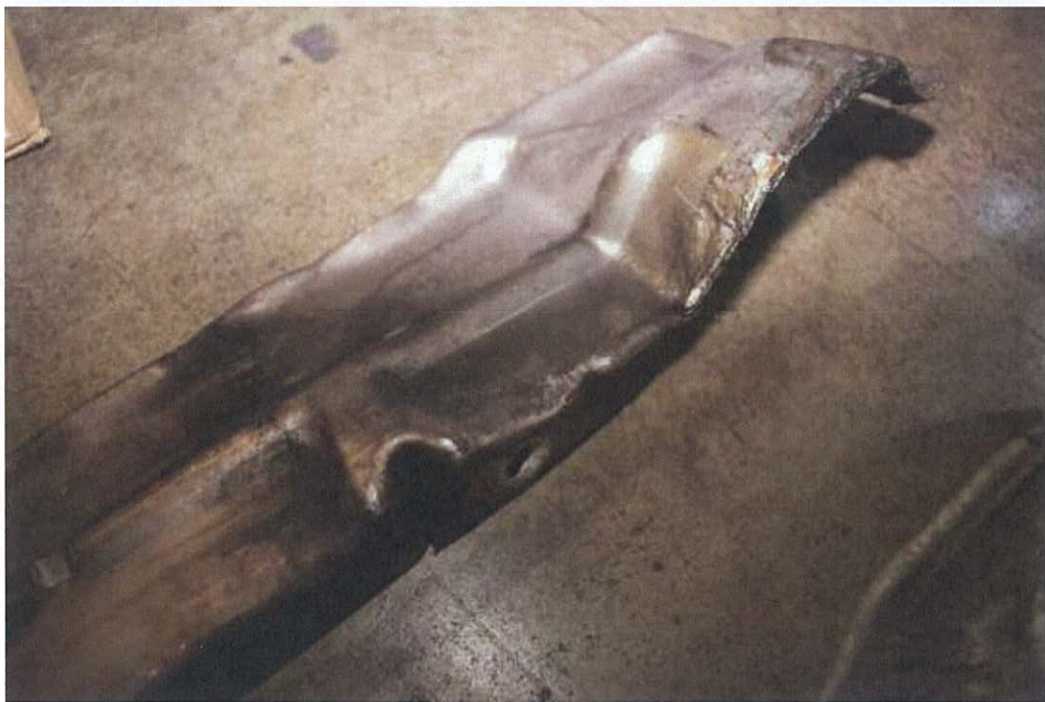
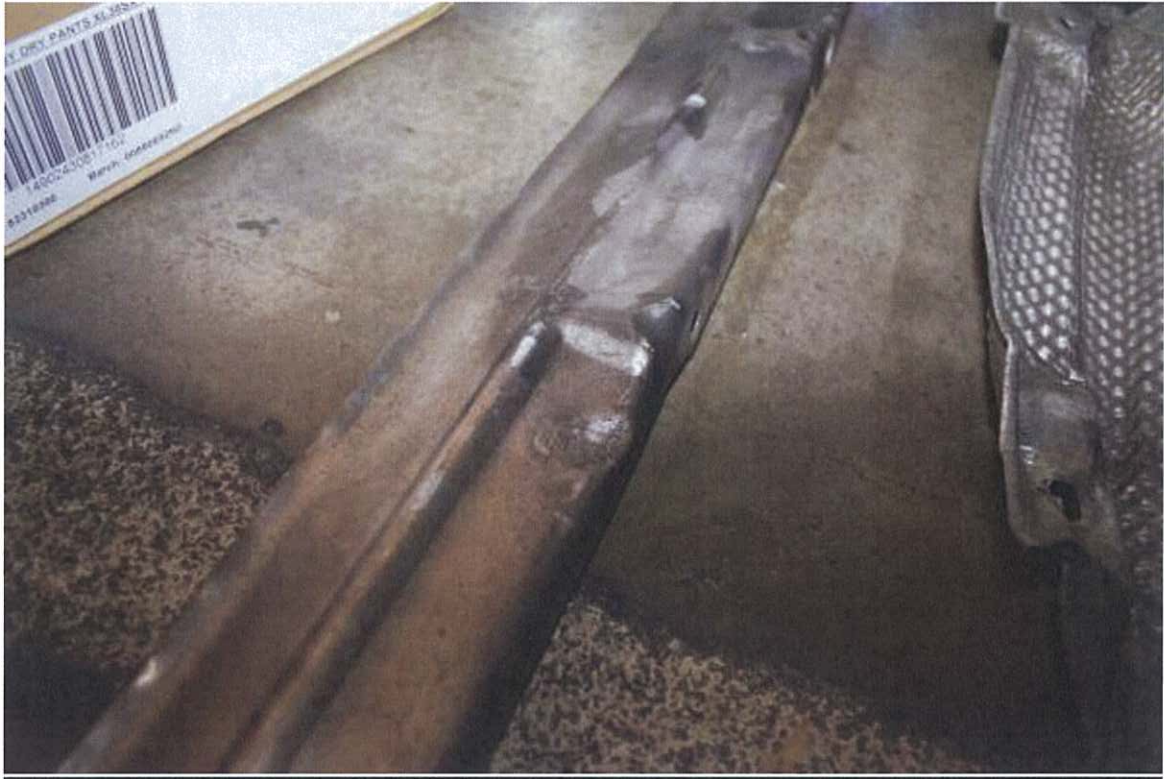
Photo 54 – Exhaust Upper Heat Plate

Photo 55 – Exhaust Upper Heat Plate

Photo 56 – Exhaust Upper Heat Plate

Photo 57 – Exhaust Upper Heat Plate

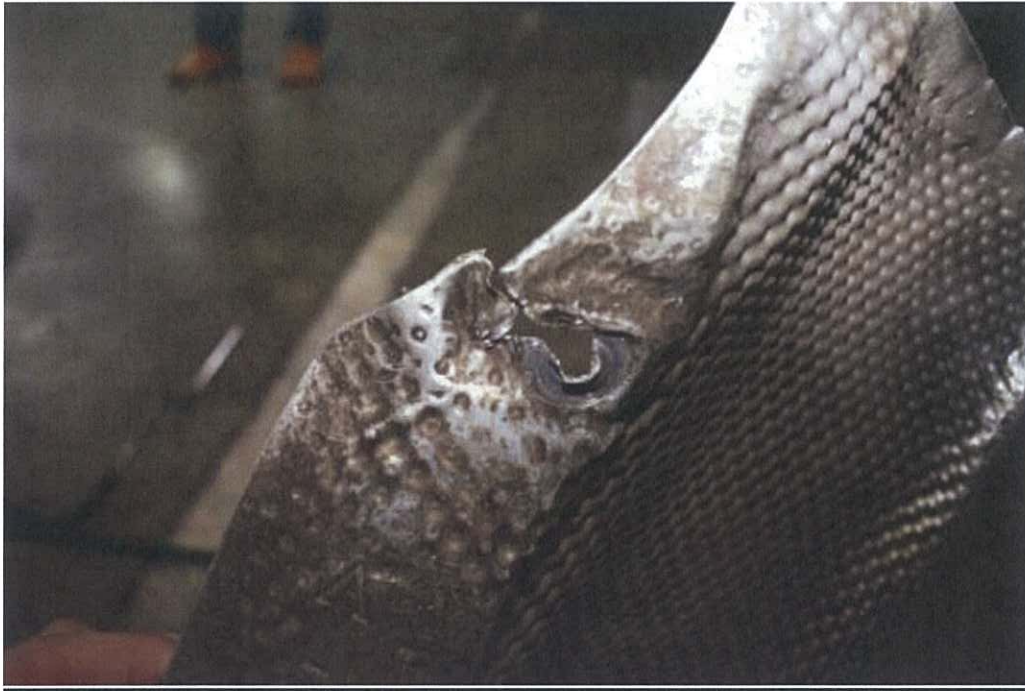
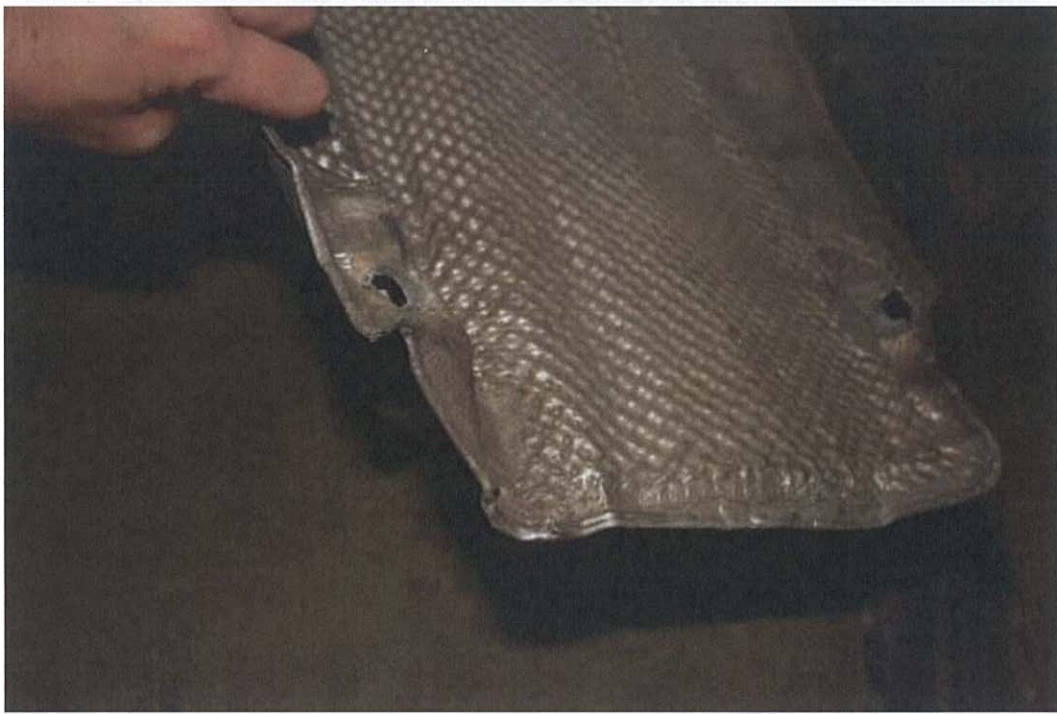
Photo 58 – Rear Exhaust Heat Shield

Photo 59 – Rear Exhaust Heat Shield

Photo 60 – Rear Exhaust Heat Shield

Photo 61 – Rear Exhaust Heat Shield

Photo 62 – Rear Exhaust Heat Shield

Photo 63 – Rear Exhaust Heat Shield

Photo 64 – Rear Exhaust Heat Shield

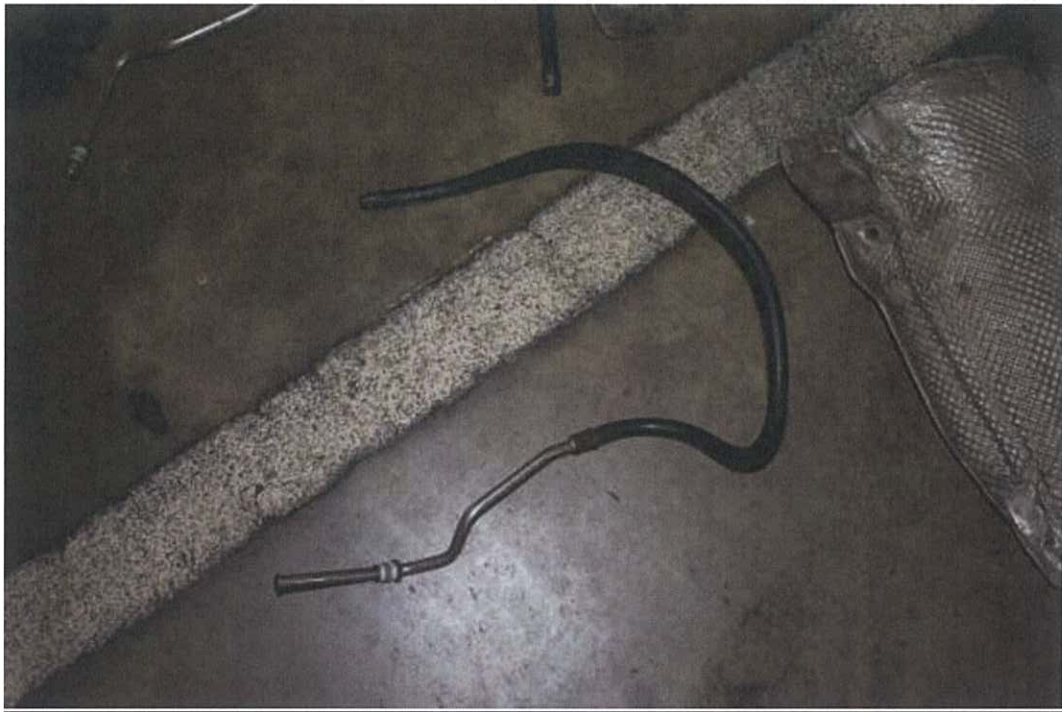
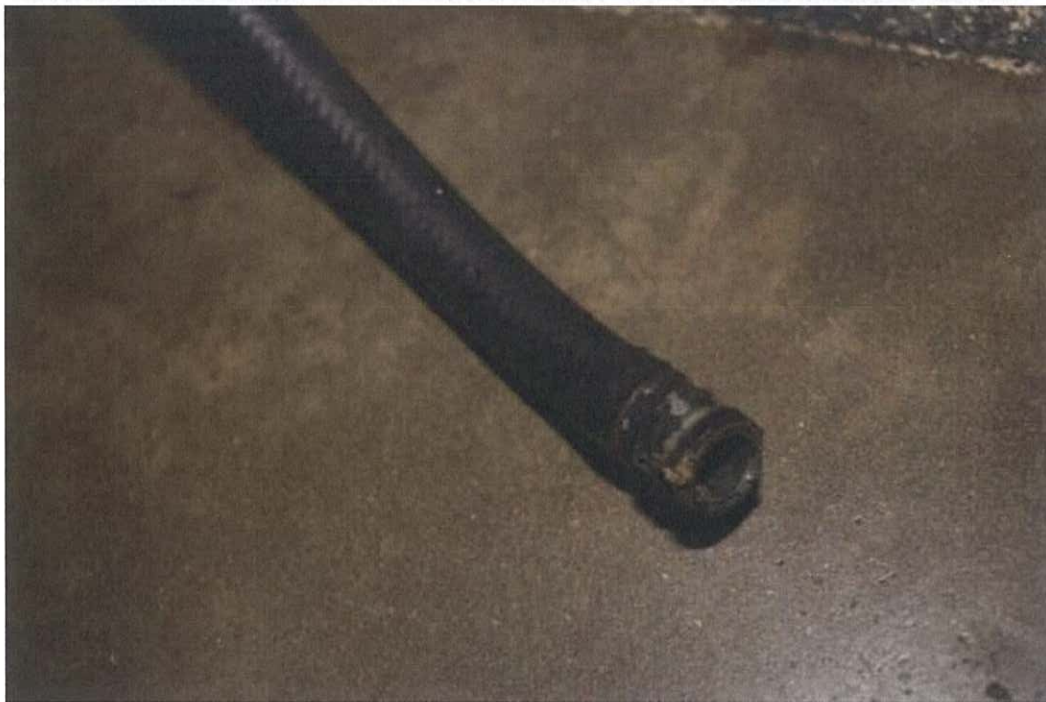
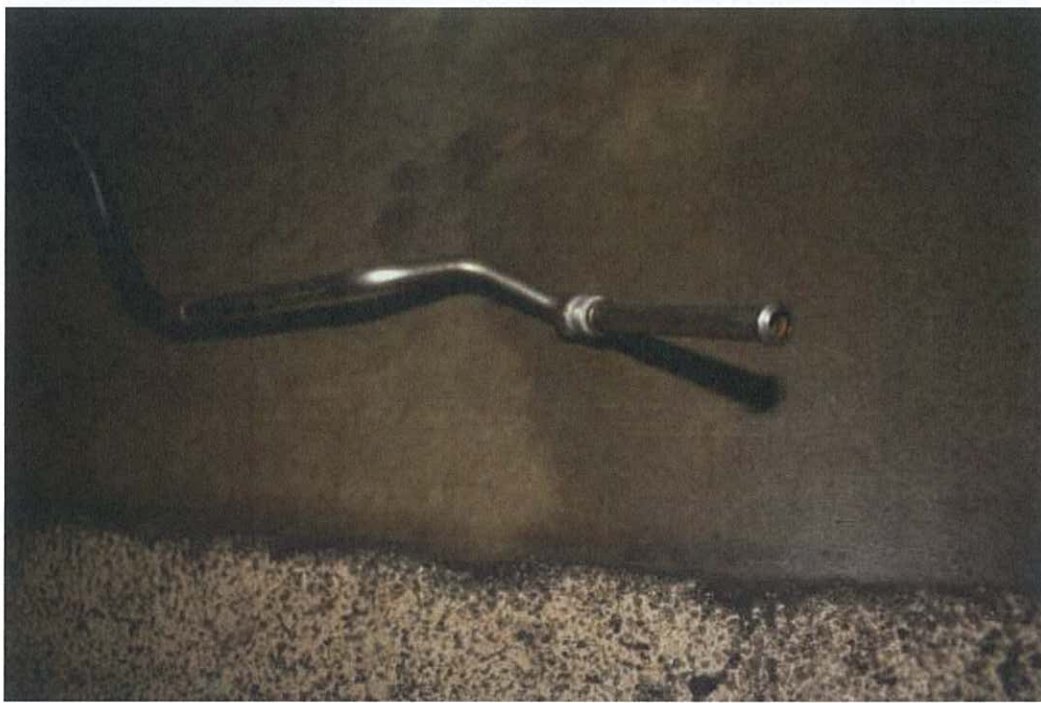
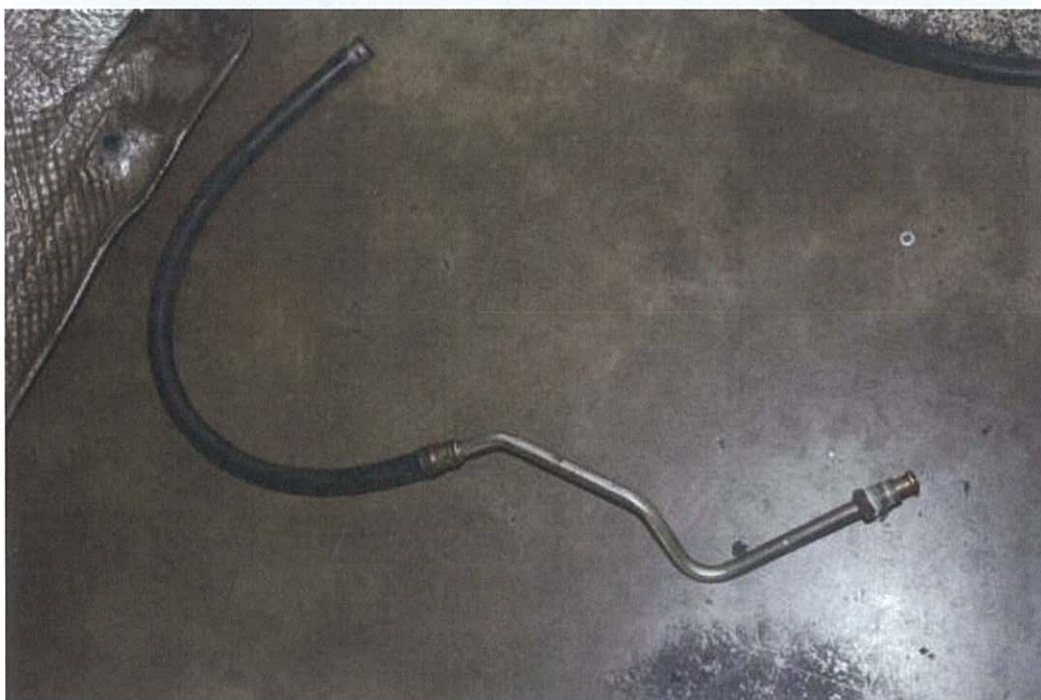
Photo 65 – Oil Pipe

Photo 66 – Oil Pipe

Photo 67 – Oil Pipe

Photo 68 – Oil Pipe

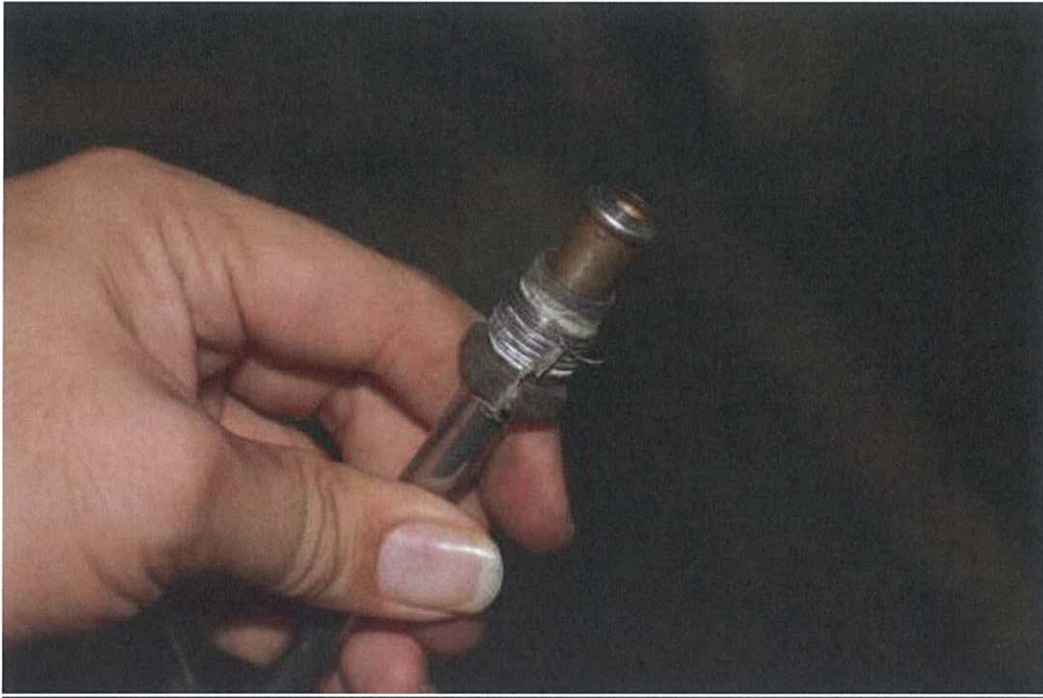
Photo 69 – Oil Pipe

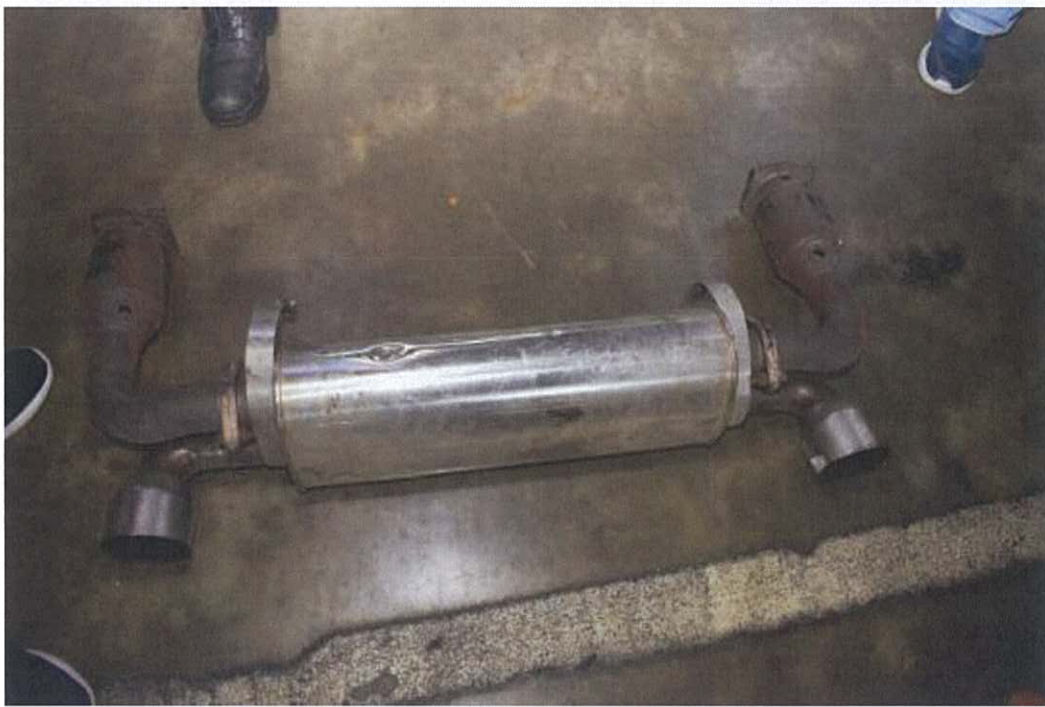
Photo 70 – Rear Exhaust Muffler

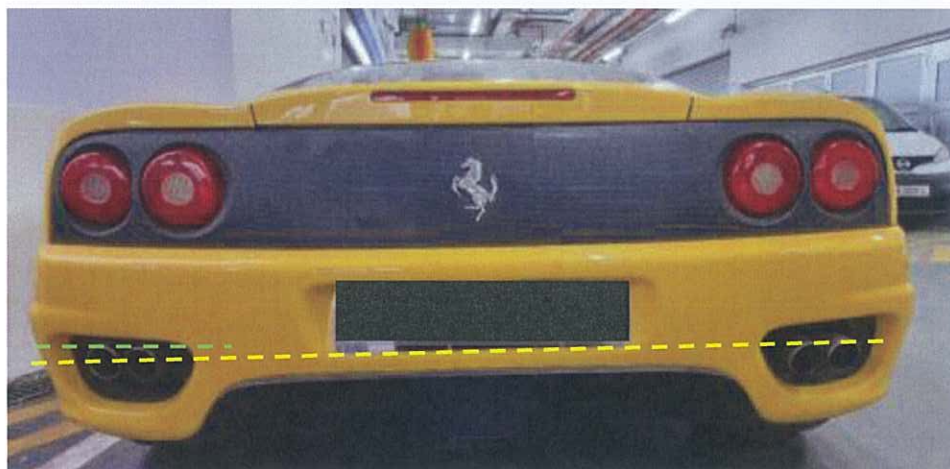
Photo 81 – Height difference indicated in yellow and green lines

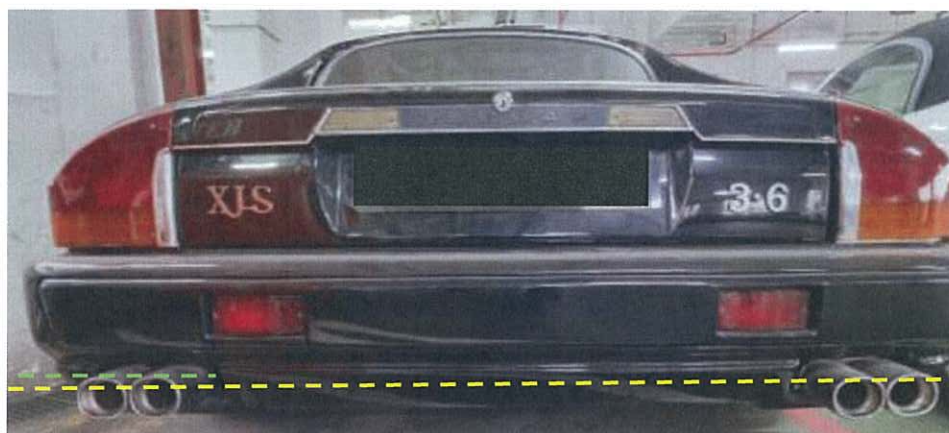
Photo 82 – Height difference indicated in yellow and green lines

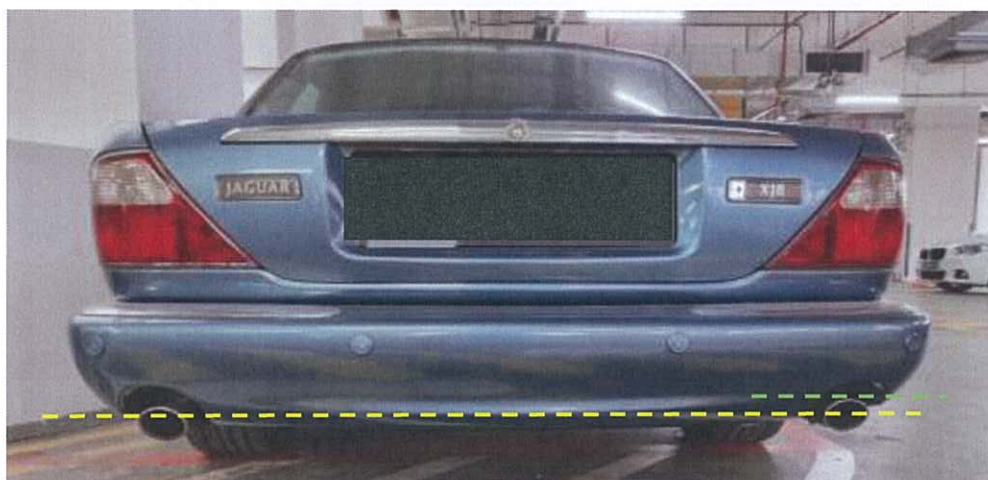
Photo 83 – Height difference indicated in yellow and green lines
